Service Bulletin

Bulletin No.: 17-NA-392

Subject: Rattle/Rattling Noise Coming From the Rear Passenger Side Floor of the Cab

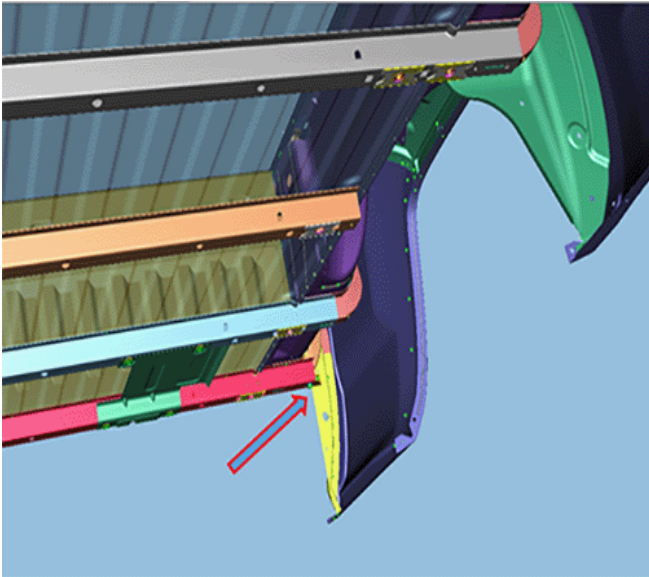
</div> <p>4918362</p> <p>The cause of the condition may be that a small population of trucks built at the Fort Wayne Assembly Plant may have a pickup box brace that can loosen due to insufficient torque of the passenger side attachment bolts. Once loose, the brace may move slightly causing a rattling noise.</p>
Correction	Verify the condition, and repair as necessary, following the Service Procedure below.

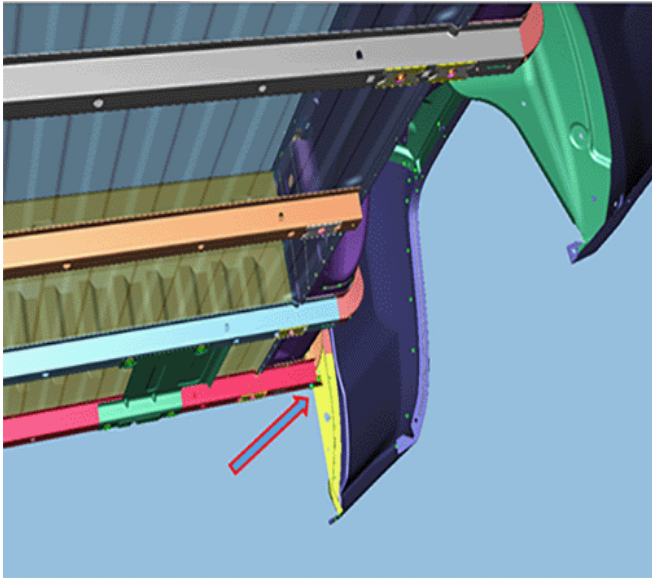
4918362

2. Inspect the right front pickup box cross member brace for looseness.
