Service Bulletin

Bulletin No.: 17-NA-402

Subject: No Crank/No Start/No Scan Tool Communication - Crank/No Start/No Fuel Pressure/
Fuel Pump Inoperative - Extreme Cold Weather

Brand:	Model:	Model Year:		VIN:		Engine:	Transmission:
		from	to	from	to		
Chevrolet	3500/4500 Low Cab Forward Medium Duty	2016	2017	SOP	1HS800009	LC8, L96

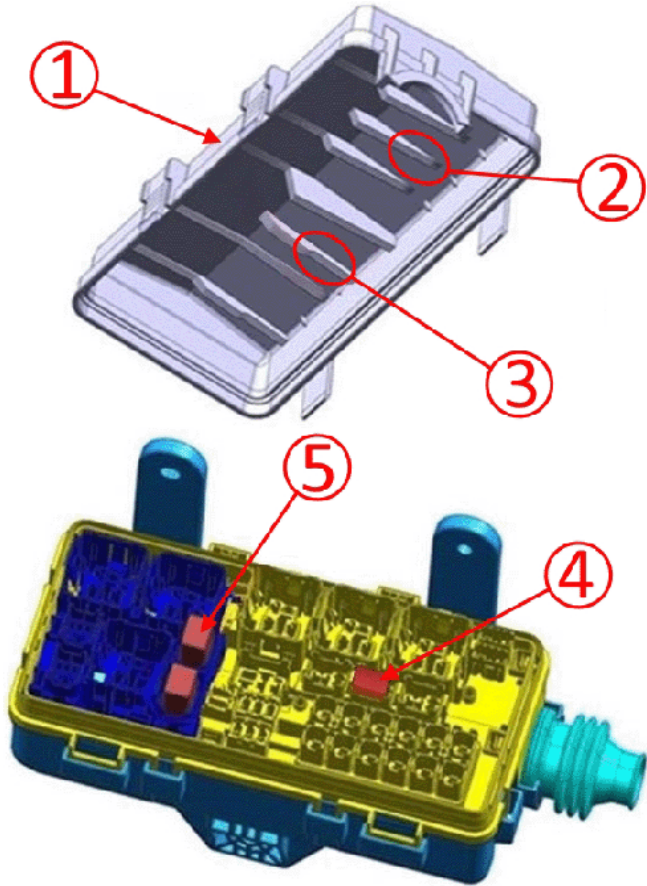
4868236

Involved Region or Country	United States
Condition 1	<p>Some customers may comment that when ambient temperatures fall to or below $-20^{\circ}\text{C}/-4^{\circ}\text{F}$:</p> <ul style="list-style-type: none"> • No crank • No start • No Communication with ECM <p>The technician may find DTC P1464 set.</p> <p>Some customers may also comment that P1464 is displayed on the Multi Information Display (MID).</p>
Condition 2	<p>Some customers may comment that when ambient temperatures fall to or below $-20^{\circ}\text{C}/-4^{\circ}\text{F}$:</p> <ul style="list-style-type: none"> • Crank • No start <p>The technician may find:</p> <ul style="list-style-type: none"> • No fuel pressure • Fuel Pump Inoperative • DTC P1464 set <p>Some customers may also comment that P1464 is displayed on the Multi Information Display (MID).</p>
Cause	This condition may be caused by a stuck/frozen X-22 and/or X-28 ECM main relay.

1. Remove the relay box cover (1).
2. Remove the original ECM Main Relay in locations X-22 or X-28.

3. Install the new relay at locations X-22 (4) or X-28 (5).
4. Locate the relay box cover rib(s) (2, 3).
5. Trim the relay cover rib(s) approximately 3 mm to provide clearance for the new relay(s).
6. Install the relay cover and confirm it seals properly.
 - If the cover does not close properly, trim additional material from the cover until it correctly seals.
