NUMBER: 08-028-17

GROUP: Electrical

DATE: March 17, 2017

RA3 And RA4 Radio Over The Air Software Updates

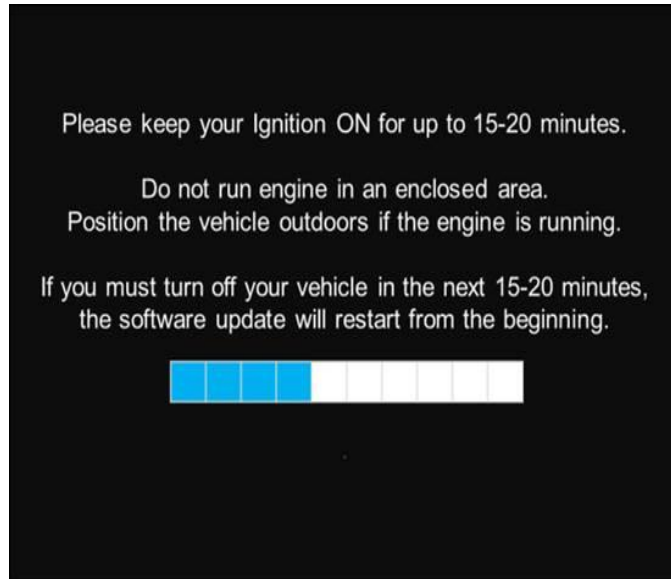
Fig. 2 First Phase

NOTE: If the ignition is turned off during the first phase, the customer will be required to restart the entire process from the beginning. The software acceptance screen will not appear again.

2. Press “Update Now” to start the first phase of the software update. The first phase will take up to 15-20 minutes to complete (Fig. 2).

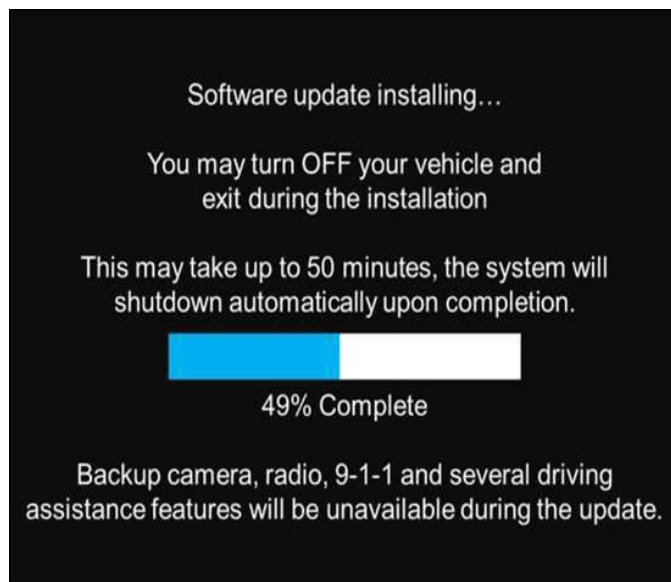
Fig. 4 Second Phase

NOTE: The second phase screen will show the completion bar go to 49% quickly and will then stay at that percentage for a longer period of time. The install is not broken/frozen.

4. Once the update has reached the second phase, the message on the touchscreen will tell you that you can turn off the vehicle, exit and let the process complete on its own (Fig. 4).
