Service Bulletin

Subject: Information on Liftgate Glass Breakage

Brand:	Model:	Model Year:		VIN:		Engine:	Transmission:
		from	to	from	to		
Chevrolet	Equinox	2015	2017			All	All

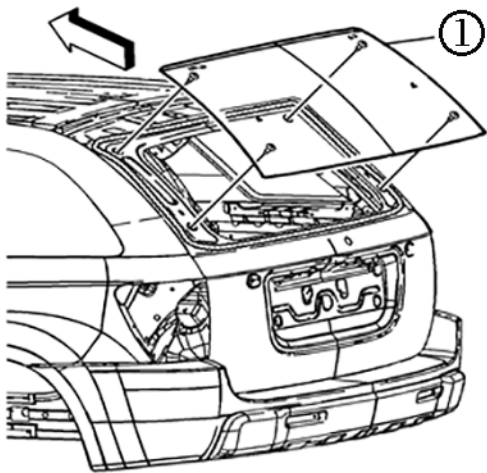
Involved Region or Country	North America, Israel
Condition	Some customers may comment that the liftgate glass has shattered, or blown outward, while driving vehicle or when a side door was closed.
Cause	The cause of the condition may be a weakness/defect in the liftgate glass. In some cases, the liftgate spoiler may also be found to contact the glass, causing an interference condition that damages the glass.

First investigate the cause; inspect the liftgate for any evidence of physical damage and inspect rear of vehicle for any unsecured objects which may have impacted the glass.

Replace liftgate glass (1) under warranty if failure is determined to be caused by glass defect. Refer to *Liftgate Window Replacement* in SI, **PLUS** follow the additional Spoiler Insulator Pads Installation steps below:
