Service Bulletin

Bulletin No.: 17-NA-383

Subject: Malfunction Indicator Lamp (MIL) Illuminated with DTC P0446 or P0455 Set

Brand:	Model:	Model Year:		VIN:		Engine:	Transmission:
		from	to	from	to		
Buick	Encore	2013	2017			All	All
Chevrolet	Sonic	2012	2017			All	All
Chevrolet	Trax	2013	2017			All	All

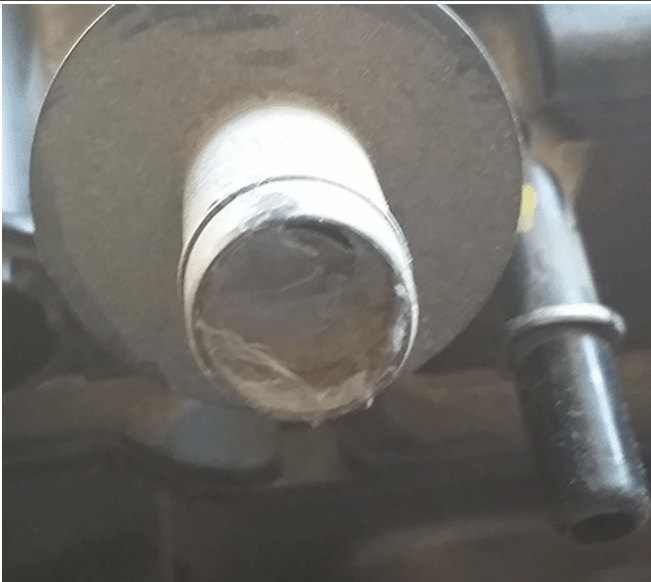
Involved Region or Country	North America
Condition	Some customers may comment on a malfunction indicator lamp (MIL) illuminated. During diagnosis, a technician may find DTC P0455 or P0446 set.
Cause	<div>

</div> <p>4646654</p> <p>This may be due to a restriction in the fresh air inlet port of the evaporator canister.</p>
Correction	Inspect and replace the canister if a restriction is found.

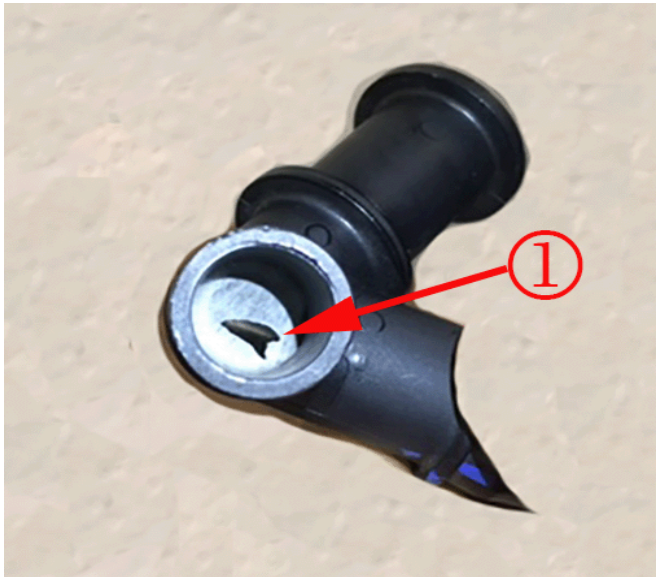
4646659

If you encounter a vehicle with the above concern, remove the evaporator canister vent cap and inspect the evaporator canister for spider nesting in the fresh air inlet port. Replace the evaporator canister. Refer to *Evaporative Emission Canister Replacement* in SI.
