Subject: Engineering Information — Driver Side Seat Air Bag Light On DTC codes B0014, B001A, B001E

Brand:	Model:	Model Year:		VIN:		Engine:	Transmission:
		from	to	from	to		
Chevrolet	Equinox Traverse	2018	2018			All	All

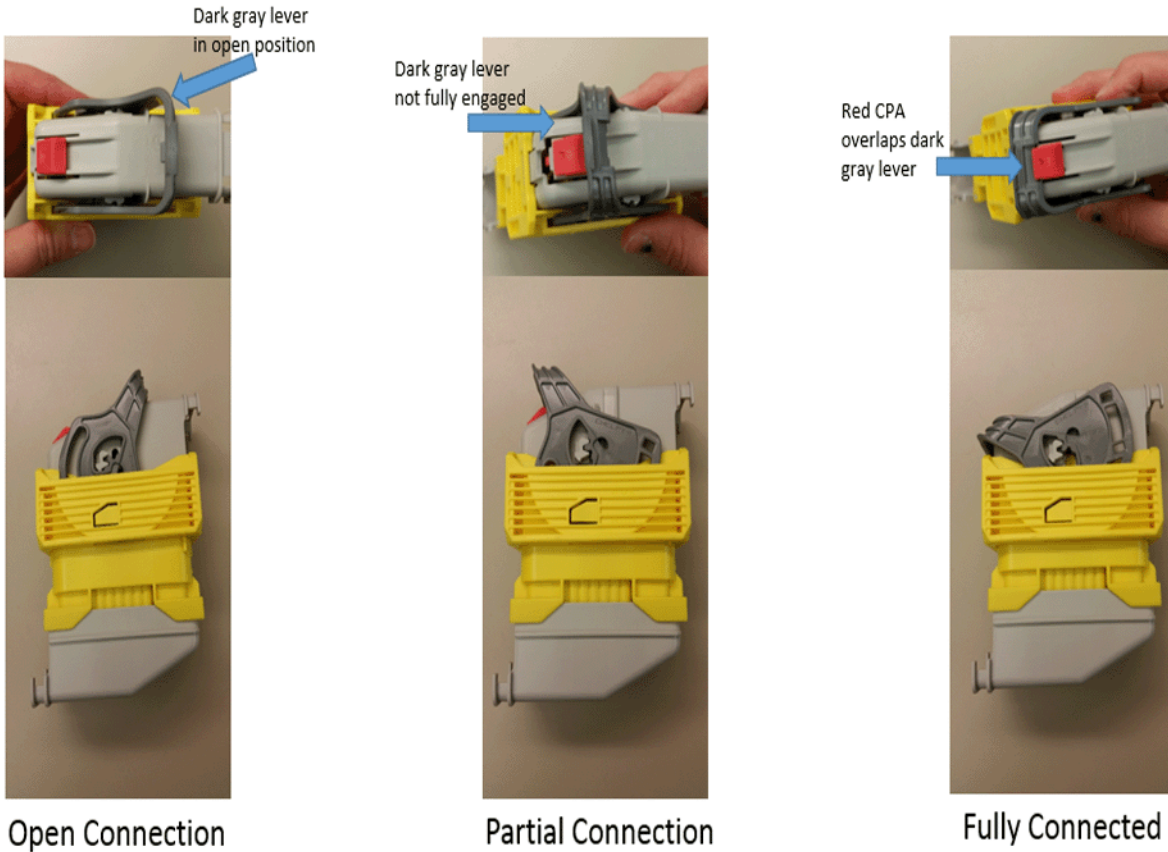
Note: Pictures showing proper engagement of connector at X301 Connector (seat to body inline connector)

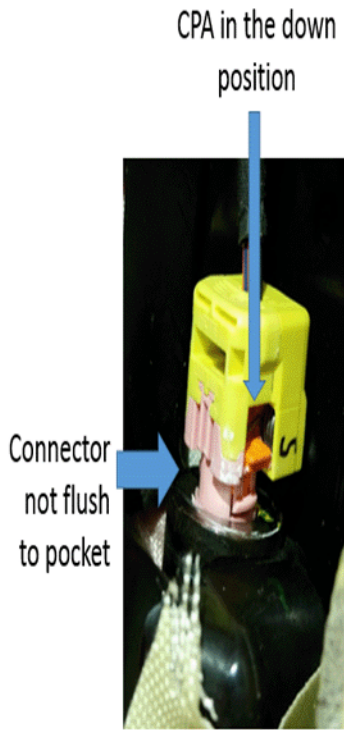
Connector not engaged

- If the connector is not fully engaged or there is damage, take zoomed out and zoomed in pictures of the condition. Fully seat the connect and verify if the DTC Code goes away.

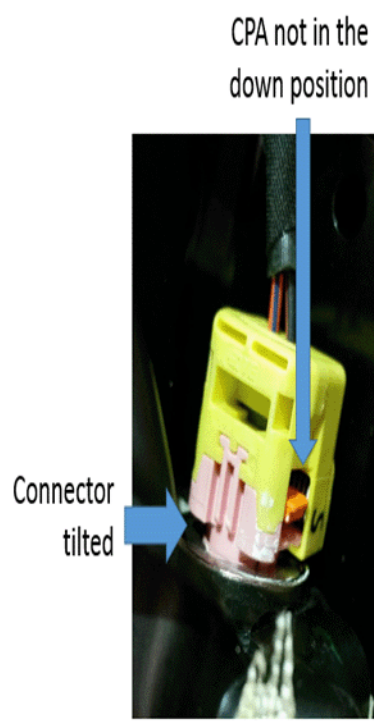
Connector partially engaged

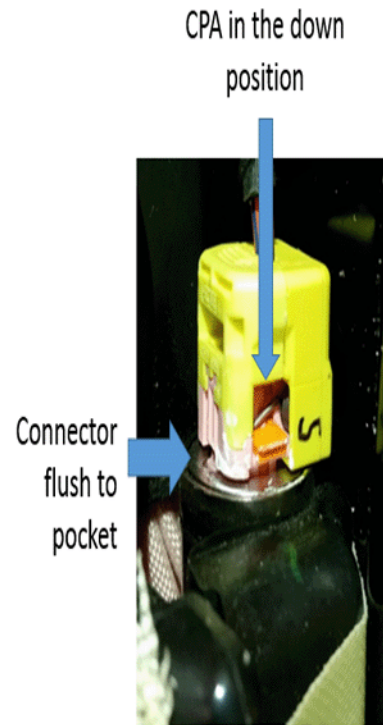
Connector completely engaged

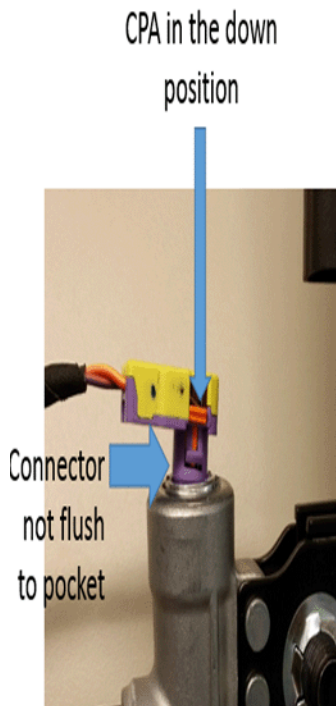
Connector not engaged

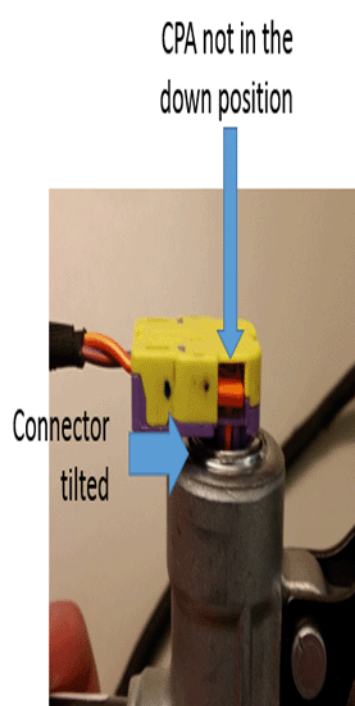
Connector partially engaged

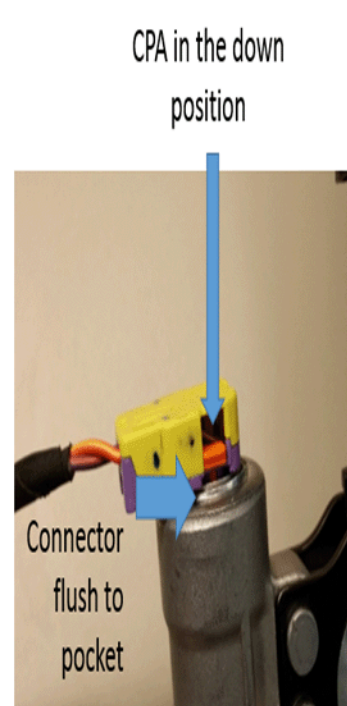
Connector completely engaged

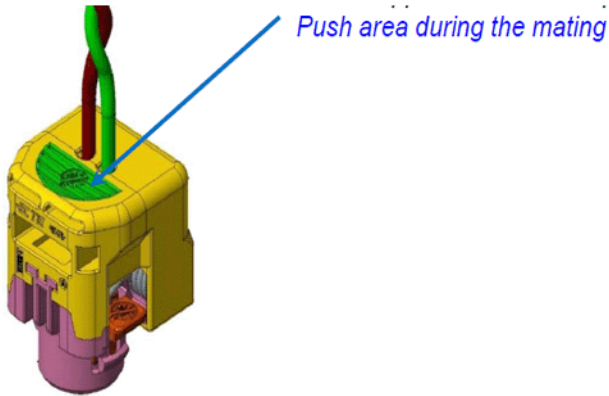
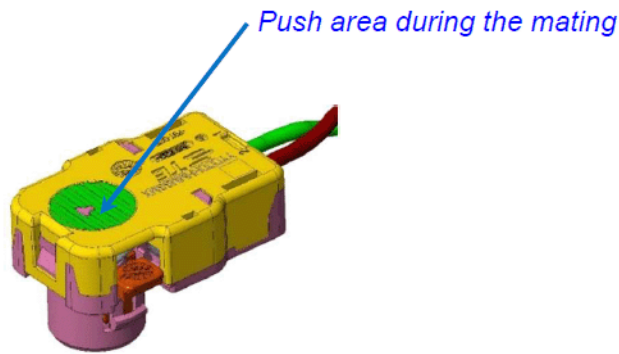
Note: Above pictures shows the area on the connector to PUSH-CLICK-PUSH to ensure fully engaged connector.
