Service Bulletin

Bulletin No.: 17-NA-097

Subject: Side Blind Zone is Not Working Correctly and/or Incorrect Side Mirror Notification

Brand:	Model:	Model Year:		VIN:		Engine:	Transmission:
		from	to	from	to		
Chevrolet	Bolt EV	2017	2017				
Opel / Vauxhall	Ampera-e	2017	2017

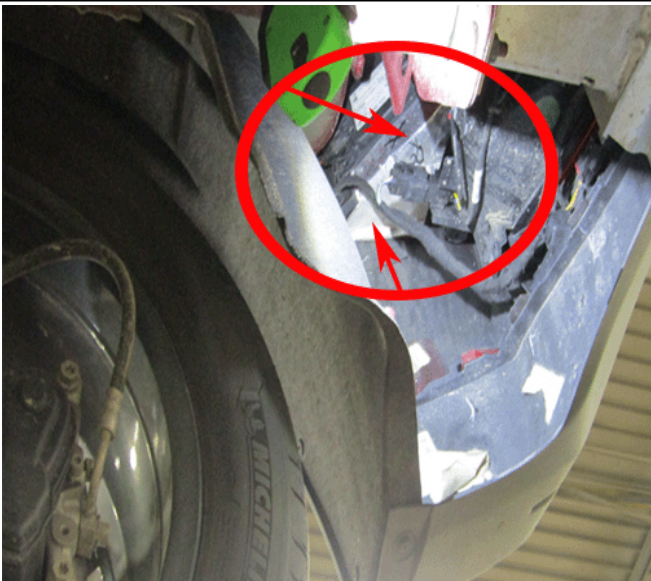
Involved Region or Country	North America, Europe, South Korea
Additional Options (RPOs)	Equipped with Side Active Safety Obstacle Detection Enhanced (RPO UKC)
Condition	<p>Some customers may comment when driving, the side mirror indicates there is a vehicle present when there actually is not.</p> <p>The technician may find one or more of the following conditions:</p> <ul style="list-style-type: none">• Wiring harness to the sensors may not be properly connected or routed.• Butyl tape not covering the sensor bracket completely.• Butyl tape missing completely.
Cause	<p>If the side blind zone has been found not working properly, inspect one or more of the following areas:</p> <ul style="list-style-type: none">• Butyl tape application at the sensor brackets.• Sensor harness electrical connection and routing.• Poor grounding at the G401 and/or G404 body ground.
Correction 1	<div>

</div> <p>4749843</p> <p>Inspect the wiring harness electrical connectors for proper connections and routing.</p>
