Service Bulletin

Bulletin No.: 17-NA-114

Subject: Oil Leak from Turbocharger Inlet or Outlet Duct

Brand:	Model:	Model Year:		VIN:		Engine:	Transmission:
		from	to	from	to		
Chevrolet	Colorado Express	2016	2018			LWN	All
GMC	Canyon Savana	2016	2018			LWN	All

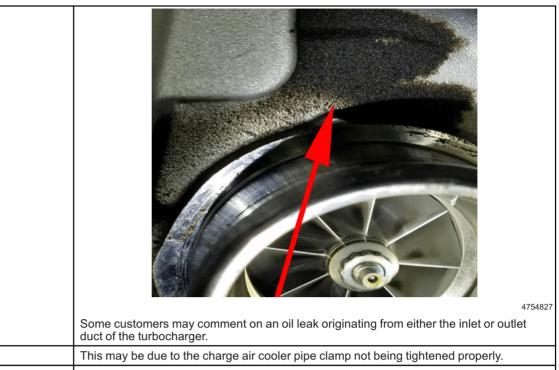
Involved Region or Country	North America and Israel
Additional Options (RPOs)	Equipped with Diesel Engine (RPO LWN)
Condition	
	4754826

aust of the tangental gen
Cause	This may be due to the charge air cooler pipe clamp not being tightened properly.
Correction	If you encounter a vehicle with the above concern, do not replace the turbocharger for this condition, instead tighten the charge air cooler pipe clamp.

Refer to Charge Air Cooler Inlet/Outlet Duct Replacement in SI for the procedure to gain access to the clamps needed to be tightened.
