Service Bulletin

Bulletin No.: 17-NA-151

Subject: Outside Noise Heard from Back of Cab

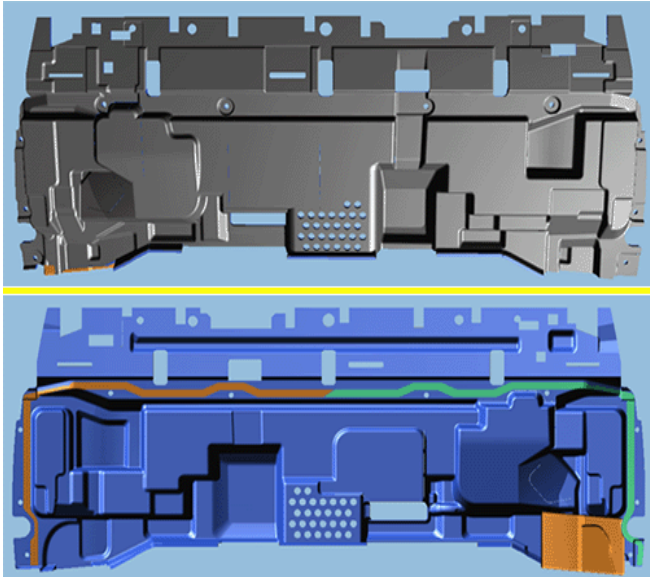
4791130

- If the vehicle contains the **3D** insulator shown in the front and rear view examples above, **DO NOT** replace the insulator. No further repairs are recommended.

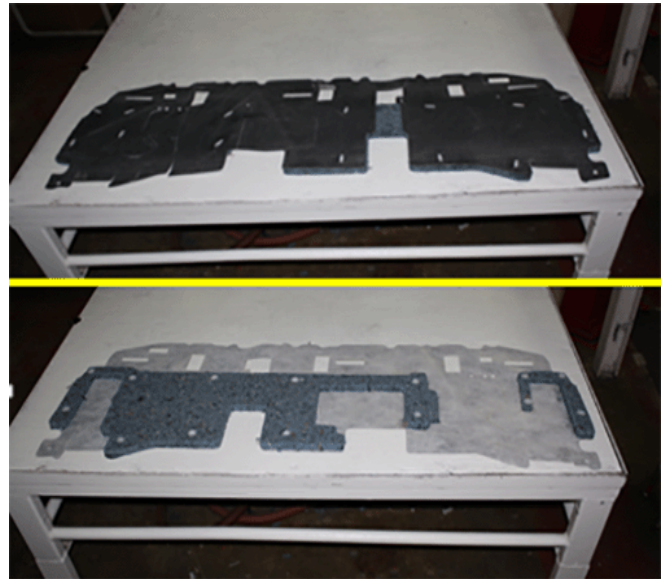
4791128

- If the vehicle contains the **2D** insulator shown in the front and rear view examples above, acoustic performance can be gained by replacing the insulator with the **3D** design. Replace the body rear panel insulator. Refer to *Body Rear Panel Insulator Replacement* in SI.
