Service Bulletin

Bulletin No.: 17-NA-219

Subject: Diagnostic Tip for Malfunction Indicator Lamp (MIL) Illuminated, Auto Stop Inoperative
- DTC P249D, P249E, U029D, U029E Set

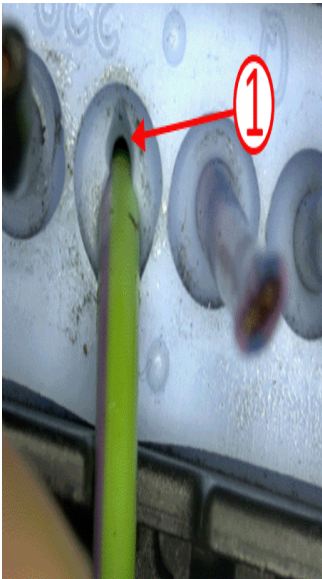
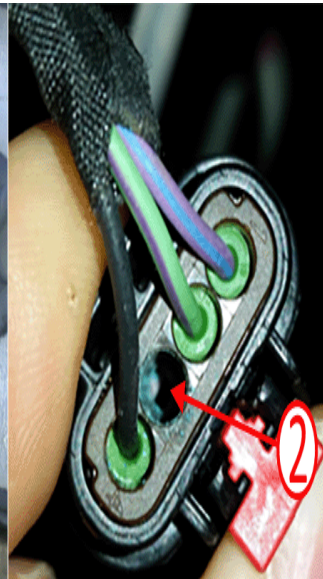
4787001

Note: The graphic above depicts an example of a torn and missing seal. <ul style="list-style-type: none">• Moisture intrusion past a damaged (1) seal located in the connector for the NOx sensor wiring harness.• Missing (2) seal located in the connector for the NOx sensor wiring harness.
Correction	If you encounter a vehicle with the above concern, perform normal diagnostics for the codes set. ⇒ If diagnostics lead to NOx sensor replacement, inspect the mating chassis electrical connector for corrosion. Clean and repair as necessary.
