## **Service Bulletin**

Bulletin No.: 17-NA-222

**Subject: Turbocharger Whine Noise**

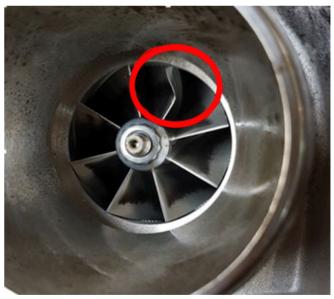
4818843

Involved Region or Country	North America and N.A. Export Regions		
Additional Options (RPOs)	Equipped with 2.8L Diesel Engine (RPO LWN)		
Condition	Some customers may comment on a whine noise during acceleration, in gear, or Neutral.		
Cause This condition may be caused by a bent turbocharger compressor blade.			
Correction	Replace the turbocharger.

If you encounter a vehicle with the above concern, inspect the turbocharger compressor blades.

If one of the blades is bent as illustrated above, replace the turbocharger. Refer to *Turbocharger Replacement* in SI
