Service Bulletin

File in Section: -
 Bulletin No.: 17-NA-255
 Date: August, 2017

Subject: Exhaust Fume Odor or Smell in Vehicle Cabin

Brand:	Model:	Model Year:		VIN:		Engine:	Transmission:
		from	to	from	to		
Chevrolet	Malibu (VIN Z)	2016	2016			LTG, LKN, LCV	All
Chevrolet	Malibu	2017	2017

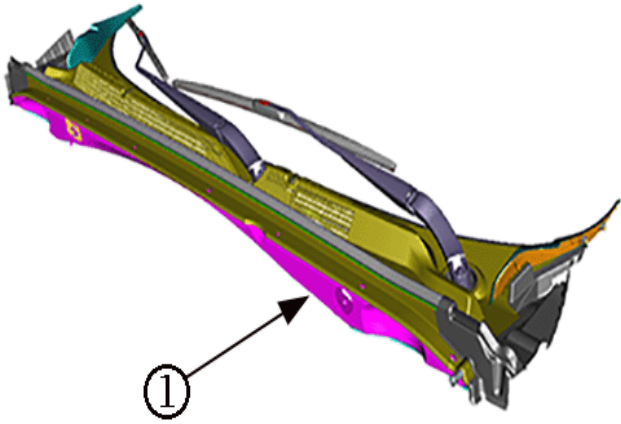
<p>①</p> </div> <p style="text-align: right; font-size: small;">4847097</p> <p>The cause of the condition may be that the original torque specification noted for the underhood dash panel upper extension panel (1) installation, was too high. This over-torque may lead to cracking the plastic panel or creating a buckling and too large of a gap between the extension panel and the plenum.</p>
Correction	Verify the condition and inspect the underhood dash panel upper extension panel following the steps in the Service Procedure below.

Important: The torque specification currently published in SI is **INCORRECT**, and is in the process of being updated. The dash panel upper extension panel attachment bolts **should be tightened to a torque of 4.5 N•m (40 lb in)**.

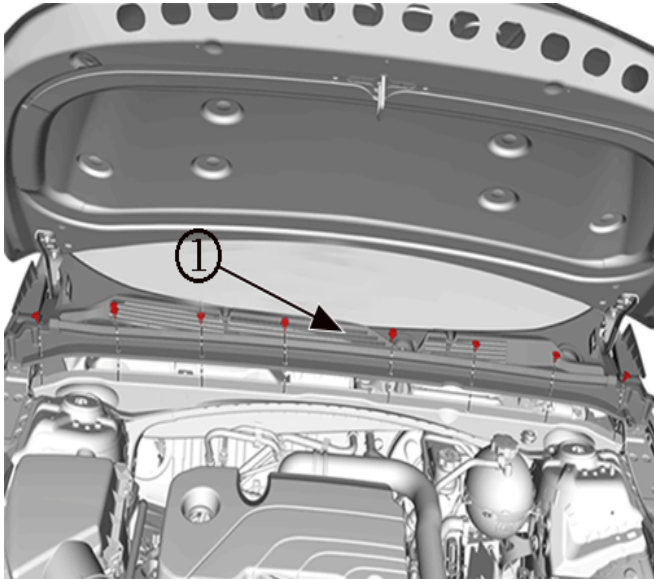
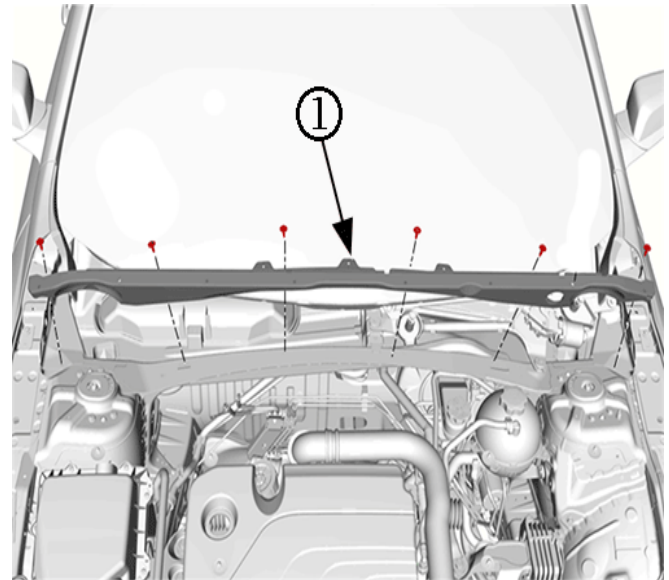
1. Remove the air inlet grille panel (1). Refer to *Air Inlet Grille Panel Replacement* in SI.
2. Visually inspect the underhood dash panel upper extension panel for cracks at the fastener locations. Also, between the fastener locations, check for buckles/gaps of over 2 mm between the extension panel and plenum.

- If the extension panel exhibits any damage or gaps, replace the panel (1). Refer to *Dash Panel Upper Extension Panel Extension Replacement* in SI.
- If no damage/gapping is found, reinstall the air inlet grille panel and refer to SI for further recommended diagnostics.
