# Service Bulletin

Bulletin No.: 17-NA-259

Date: August, 2017

**Subject:** Body Creak Noise from Rear Seat Area

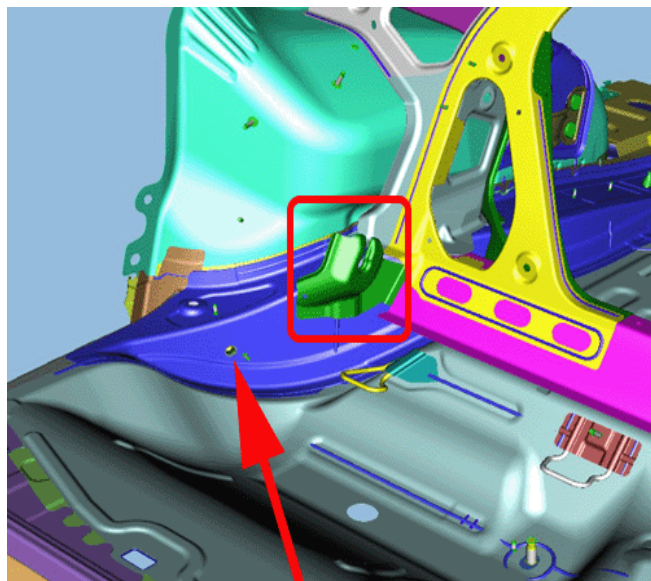
4847647

3. Insert a borescope in the lower rear seat belt retractor bolt hole on the affected side, and fish the lens toward the contact point of the bracket illustrated in green above.

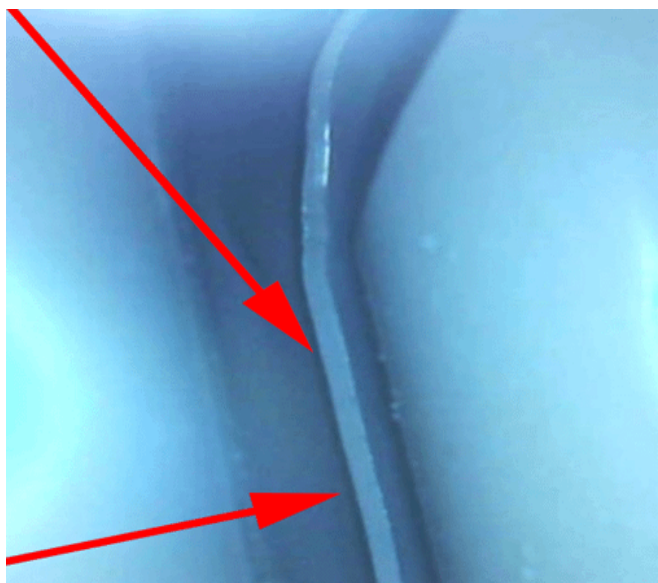
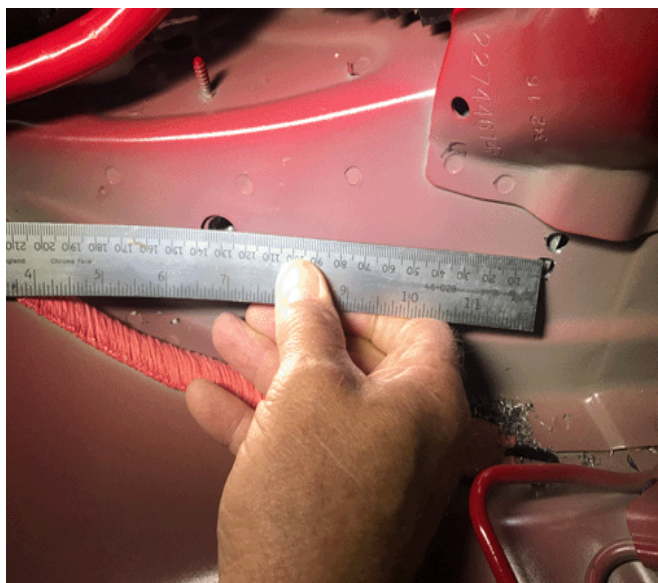
4. With the borescope inspect the two panels for either missing bond or imperfections.
- If imperfections are not visible, continue to Step 12.
