Service Bulletin

Bulletin No.: 17-NA-263

Subject: Information on Dimples and/or Crease Visible on 2nd Row Seat Back Cover Material When Seat Returned from Fold Flat Position

Brand:	Model:	Model Year:		VIN:		Engine:	Transmission:
		from	to	from	to		
Buick	Enclave	2018	2018			All	All
Chevrolet	Traverse

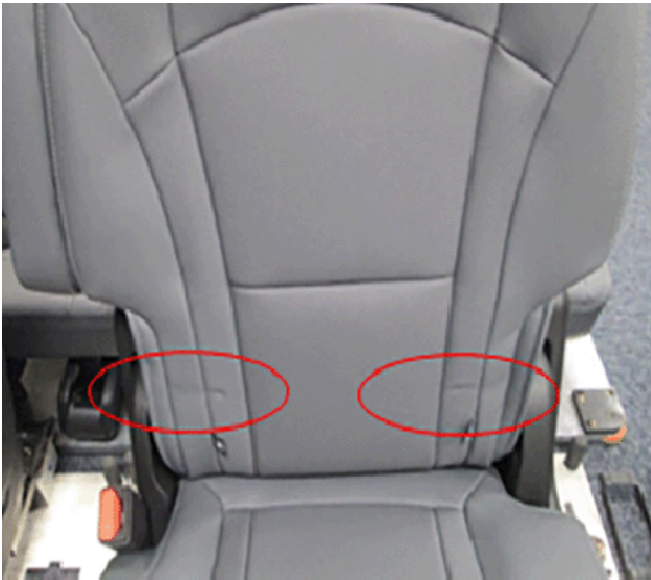
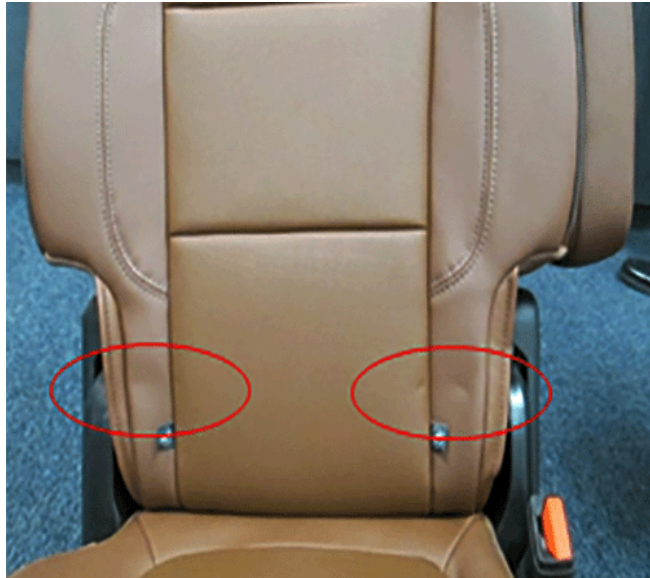
Note: Examples of how the dimples/crease may look on different seat material are shown in the graphics above.

Some customers may comment that upon returning their 2nd row seats from a fold flat to an upright position, there are dimples and/or creases visible in the lower portion of the seat back cover material.

The seats are operating properly and this is a normal condition.

The appearance of these dimples/crease is not evidence of damage, but are simply a result of the seat design. These impressions will fade and disappear over a period of time, after the seat is returned upright.

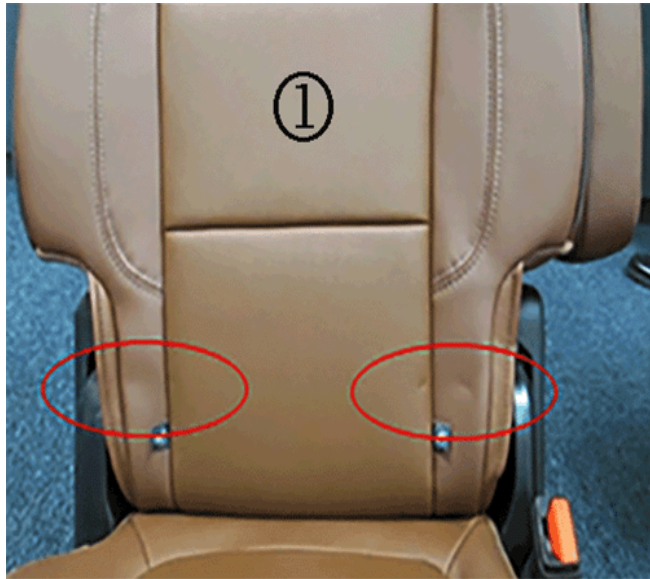
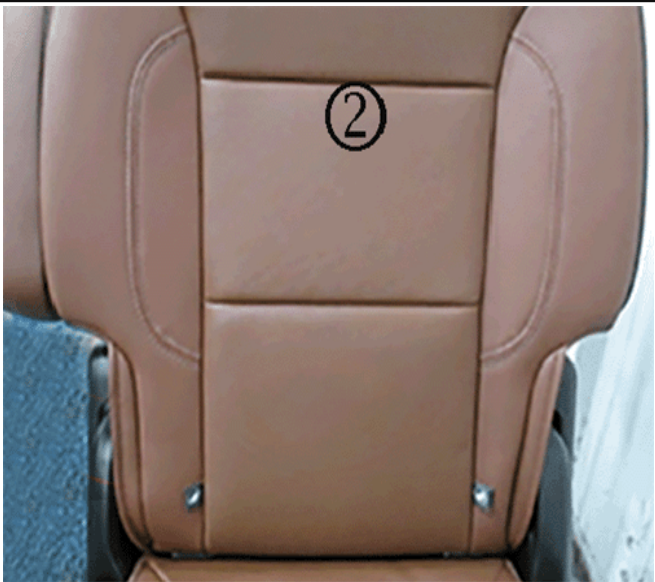
Note: The graphics above show examples of a time period between a one hour recovery (1) and a four hour recovery (2). Length of time may vary by conditions, however the impressions will fade and disappear.

Please communicate to the customer this condition is a normal operating characteristic of their vehicle. Please share this information with the customer, including a copy of this bulletin.
