# Service Bulletin

File in Section: -  
 Bulletin No.: 17-NA-265  
 Date: August, 2017

**Subject: Flutter or Boom Noise from Rear of Vehicle**

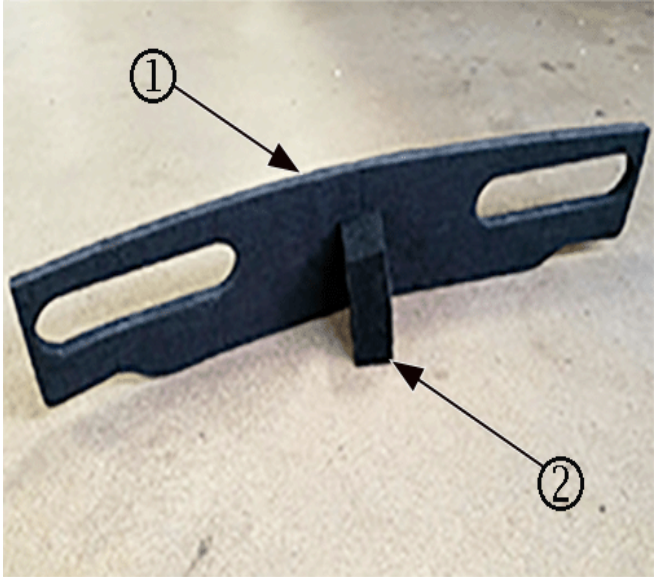
<b>Involved Region or Country</b>	North America and N.A. Export Regions
<b>Condition</b>	Some customers may comment on hearing a flutter or boom noise from the rear of the vehicle. The noise is most noticeable while driving above 40 km/h (25 mph), with the HVAC off, or in recirculation mode.
<b>Cause</b>	The cause of the condition may be the rear pressure relief valves (PRVs) opening and closing.
<b>Correction</b>

<p style="text-align: right;">4849171</p> <p><b>Note:</b> The installation of an acoustic insulator panel (1) and block (2) will help to dampen the noise.</p> <p>Verify the condition and install a rear acoustic insulator panel and block, following the repair steps in the Service Procedure below.</p>
