Service Bulletin

Bulletin No.: 17-NA-268

Subject: Diagnostic Tip for Steering Reduced Message, Stabilitrak Message, Traction Control Lamp On, Malfunction Indicator Lamp (MIL) Illuminated

Brand:	Model:	Model Year:		VIN:		Engine:	Transmission:
		from	to	from	to		
Chevrolet	Equinox	2018	2018

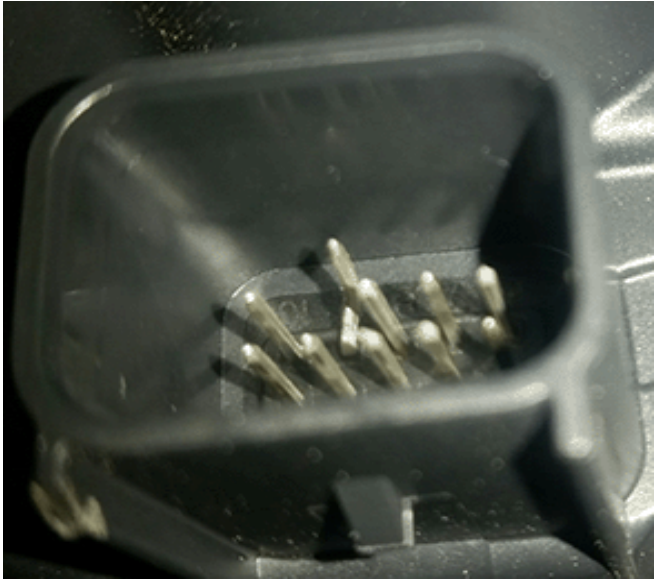
Involved Region or Country	North America and N.A. Export Regions
Condition	<p>Some customers may comment on one or more of the following conditions:</p> <ul style="list-style-type: none"> • Steering Reduced Message • Stabilitrak Message • Traction Control Lamp on • MIL <p>The technician may find one or more of the following DTCs set:</p> <ul style="list-style-type: none"> • U0121 • U0131 • U0151 • U0077 • U0077 • U0415 • U0422 • U1833
Cause	This condition may be caused by a bent terminal at the power steering gear electrical connector.
Correction	<div style="text-align: center;">

</div> <p style="text-align: right; font-size: small;">4815387</p> <p>Inspect the power steering gear electrical connection for bent terminals. If the terminals have been found bent, replace the steering gear.</p>
