Service Bulletin

File in Section: -
 Bulletin No.: 17-NA-270
 Date: August, 2017

Subject: Malfunction Indicator Lamp (MIL) Illuminated - DTC B001A 02 Set

Brand:	Model:	Model Year:		VIN:		Engine:	Transmission:
		from	to	from	to		
Chevrolet	Impala	2006	2016

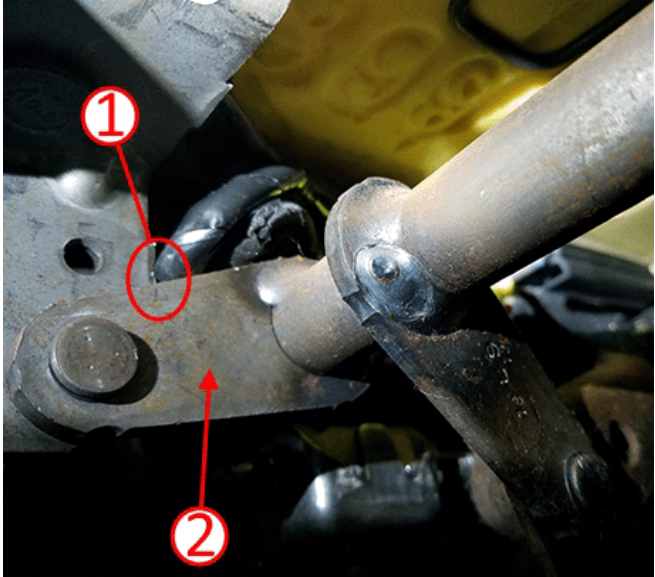
<p style="text-align: right;">4849424</p> <p>This condition may be caused by the drivers seat belt retractor pretensioner wires pinching (1) in the seat frame adjuster mechanism (2) when the seat is in the full lower position.</p>
Correction	Inspect and repair any damaged wiring and secure the harness away from the seat adjuster mechanism.
