# Service Bulletin

**Subject:** Convertible Top Creak or Snap Noise While Driving

Brand:	Model:	Model Year:		VIN:		Engine:	Transmission:
		from	to	from	to		
Chevrolet	Corvette Convertible	2014	2016			All	All

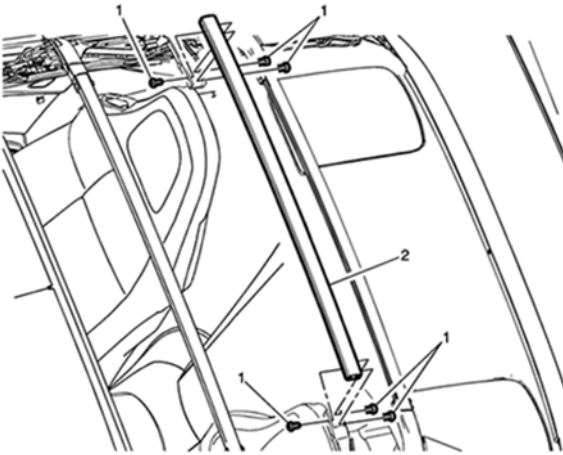
<p>The cause of the condition may be that the fasteners (1) at the ends of the #3 Bow (2) may have lost torque.</p>

Following the Service Procedure below, remove the original smaller screws and install the new large M6 screws referenced in the Part Table.
