Shift Shock on Initial Startup or Reacceleration

YEAR(S)	MODEL(S)	ADDITIONAL INFORMATION	
2018	Camry

TOYOTA T-SB-0330-17 December 11, 2017 Page 2 of 6

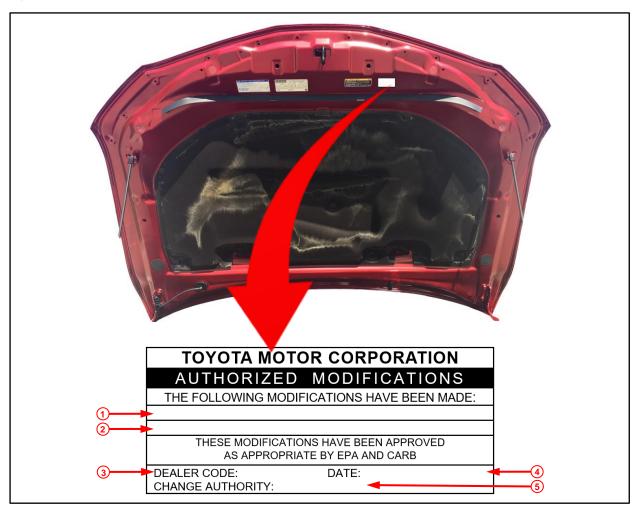
Figure 1. Location of Authorized Modification Label on 2018 Camry

1	Replacement ECM (PCM) Part Number (i.e., 89661-06X53)
2	New Calibration ID (i.e., 89663-33P30)
3	Dealer Code

4	Date Completed
5	This SB Number

2. Check for the Authorized Modification Label affixed to the vehicle in the applicable location shown below.
