April 2017  
FL731A-G  
NHTSA #17V-043  
Transport Canada #17-031

## **Subject: ICU3S Dual Cluster Displays**

**Models Affected: Specific Freightliner 108SD, 114SD, and Business Class M2 vehicles manufactured March 5, 2015, through August 15, 2016.**

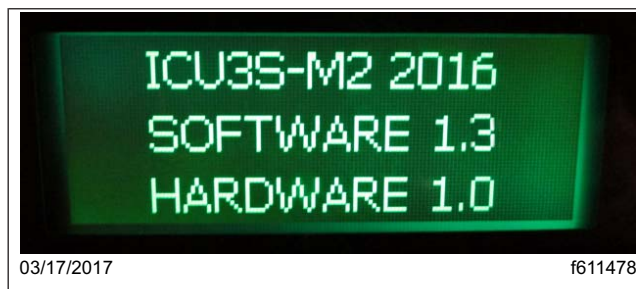
**Fig. 1, ICU3S Screen Showing Software Version 1.3  
(correct)**

If the software level of the ICU3S is 1.3, or higher, no further action is necessary. Continue with step 19.

If the software level is below 1.3, continue with the next step.

1. Check the base label (Form WAR259) for a completion sticker for FL731 (Form WAR260) indicating this work has been completed. The base label is usually located on the passenger-side door, about 12 inches (30 cm) below the door latch. If a completion sticker is present, no work is needed. If a completion sticker is not present, proceed to the next step.
2. Park the vehicle, shut down the engine, and apply the parking brakes. Chock tires.
3. Press the ICU3S mode button until the software/hardware versions display on screen. Verify the software level of the ICU3S. See [Fig. 1](#).
