Service Information Bulletin

SUBJECT	DATE
SPN 521222 (TCM)	April 2017

2 SPN 521222/FMI 19

TCM – No CAN Data Received from CPC

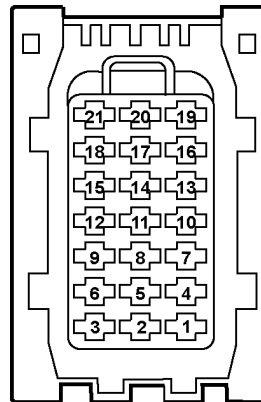
45801

3. Disconnect the TCM X1 21-pin connector.
4. Inspect TCM X1 21-pin connector for corrosion, water intrusion or pin damage. Are any pins damaged?
 - a. Yes; repair as necessary.

- b. No; Go to step 5.
5. Turn the ignition ON (key ON, engine OFF).
6. Measure the voltage between TCM X1 21-pin connector pins 1, 2, 3, 4, 6 (ignition/battery voltage), and ground. Is the voltage less than 11.5 volts?

- a. Yes; restore voltage to TCM X1 21-pin connector pins 1, 2, 3, 4, and 6.
 - b. No; Go to step 7.
7. Turn the ignition OFF.
8. Measure the resistance between TCM X1 21-pin connector pins 16, 19, 20, 21, and the negative battery post. Is the resistance greater than three ohms?
 - a. Yes; restore battery ground to TCM X1 21-pin connector pins 16, 19, 20, and 21.
 - b. No; Go to step 9.
9. Measure the resistance between TCM X1 21-pin connector pins 10 and 11. Is the resistance between 55 and 65 ohms?
 - a. Yes; replace the Transmission Control Module (TCM).
 - b. No; repair Powertrain Controller Area Network (CAN) harness.
 For GHG14; Refer to section "SPN 625/FMI 13 – GHG14" for further diagnostics.
 For GHG17; Refer to section "SPN 625/FMI 13 – GHG17" for further diagnostics.
