No.: 17 TS-11
April 25, 2017

SUBJECT: **Detroit™ DT12™ Transmission Proper Moving Procedure**

Note: This document supersedes 15 TS-15.

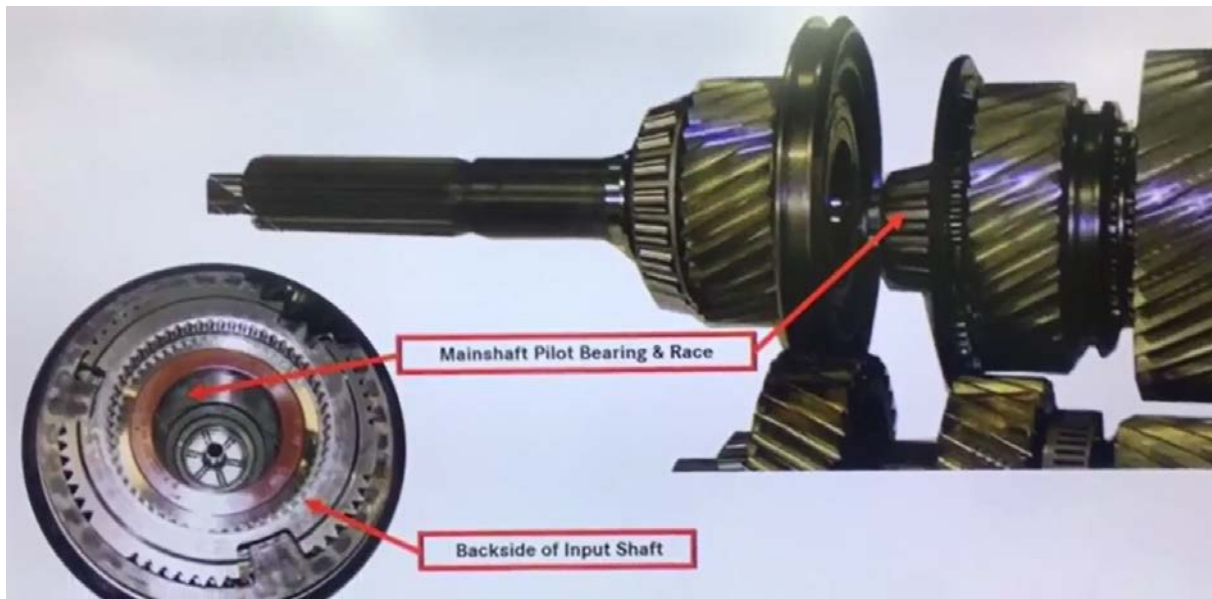
Figure 1 – Mainshaft Pilot Bearing Location

The DT12™ oil pump does not rotate when the vehicle is towed or pushed incorrectly. Therefore, internal transmission components will not receive adequate lubrication. The mainshaft will turn, as will the mainshaft pilot bearing. The mainshaft pilot bearing fits into a matching race in the input shaft, which will not turn. Given the large loads on the mainshaft pilot bearing, the lack of lubrication from improper towing or pushing can lead to failure of the mainshaft pilot bearing. See Figure 1 for the location of the mainshaft pilot bearing. A supplemental video showing the mainshaft pilot bearing can be found on ddcsn.com > Support > Multimedia > DT12 Transmission > DT12 Mainshaft Pilot Bearing.

When towing from the front or pushing a DT12™ equipped truck, with the rear wheels on the ground, driveshaft removal is preferred. If driveshaft removal is not possible, **ALL DRIVE** axle shafts **MUST** be removed. There must not be any physical connection between the drive axle(s) and the transmission.
