Diesel Exhaust Fluid (DEF) Pressure Line Disconnected at the Doser Connection **49-019**

**Western Star Service
Bulletin**

Western Star Service Bulletin , 11/28/2017

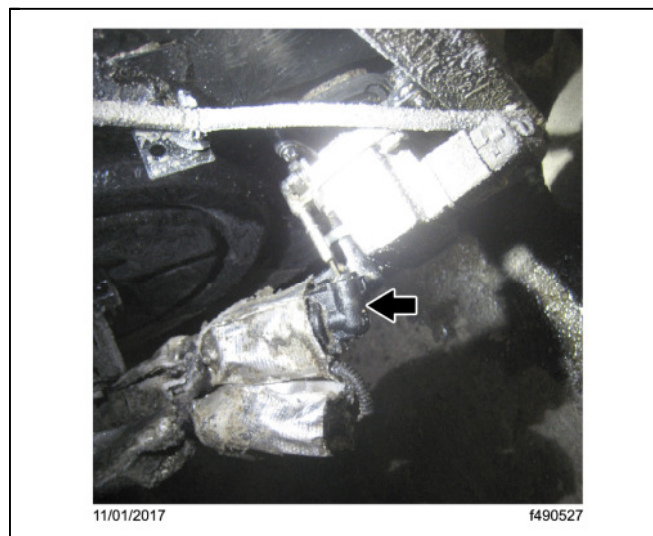
On some GHG14 and GHG17 vehicles equipped with a Detroit one-box aftertreatment system (ATS), the DEF pressure line may be pushed off the doser connection by frozen DEF in extreme cold climates. See Fig. 1 . Going forward, vehicles equipped with a Detroit Diesel one-box ATS will have a zip tie installed through the doser mounting bracket and around the DEF pressure line.

Fig. 1, DEF Line Broken

Installing the zip tie (part number 23-09796-509) prevents the DEF pressure line from being pushed off. The zip tie can be installed as a preventive measure or can be installed after the DEF line is disconnected, without replacing the DEF line.

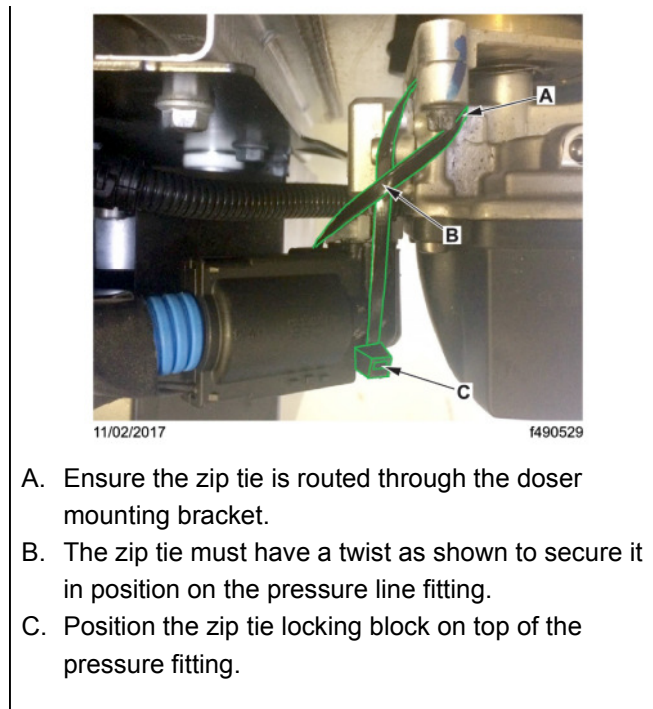
Fig. 2, Installing a Zip Tie on the DEF Pressure Line and Doser

1. Park the vehicle on a level surface, shut down the engine, and set the parking brake. Chock the tires.
2. Locate the DEF pressure line on the ATS.
3. Install a zip tie on the DEF pressure line and doser as shown in Fig. 2 .
