Diesel Exhaust Fluid (DEF) Pressure Line Disconnected at the Doser Connection **49-040**

> Cascadia Cargo FLB COE	Columbia Argosy COE FLD Conventional FLA COE	Freightliner Service Bulletin
> Business Class M2	> New Cascadia	
> 108SD/114SD Century Class Conventional Business Class	> FLC 112 Conventional > 122SD and Coronado

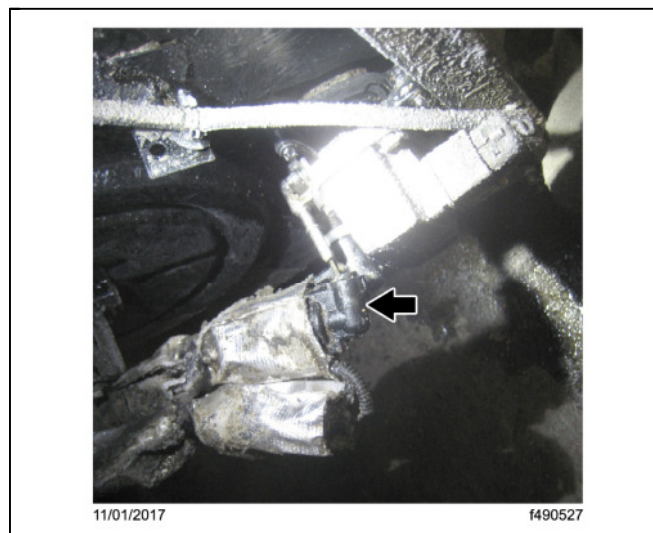
On some GHG14 and GHG17 vehicles equipped with a Detroit one-box aftertreatment system (ATS), the DEF pressure line may be pushed off the doser connection by frozen DEF in extreme cold climates. See Fig. 1 . Going forward, vehicles equipped with a Detroit Diesel one-box ATS will have a zip tie installed through the doser mounting bracket and around the DEF pressure line.

Fig. 1, Broken DEF Line

Installing the zip tie (part number 23-09796-509) prevents the DEF pressure line from being pushed off. The zip tie can be installed as a preventive measure or can be installed after the DEF line is disconnected, without replacing the DEF line.

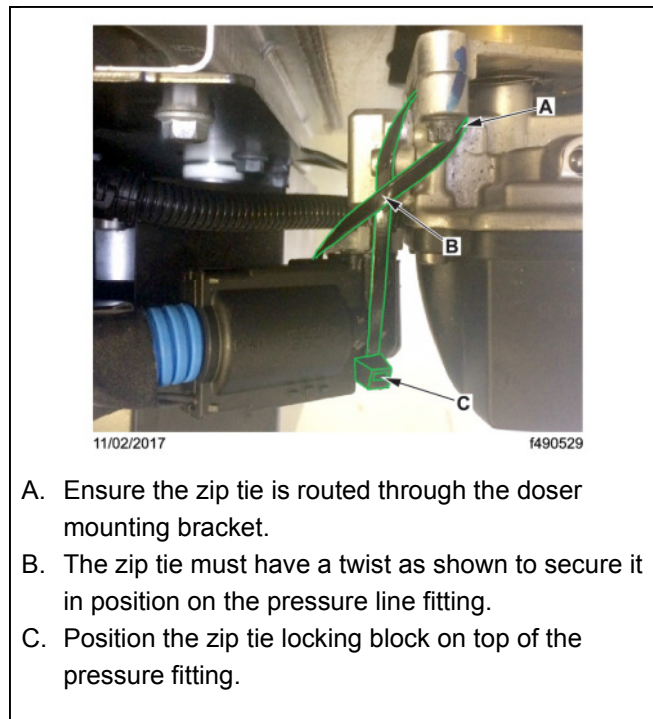
Fig. 2, Installing a Zip Tie on the DEF Pressure Line and Doser

1. Park the vehicle on a level surface, shut down the engine, and set the parking brake. Chock the tires.
2. Locate the DEF pressure line on the ATS.
3. Install a zip tie through the doser mounting bracket and around the DEF pressure line as shown in Fig. 2 .

- A. Ensure the zip tie is routed through the doser mounting bracket.
- B. The zip tie must have a twist as shown to secure it in position on the pressure line fitting.
- C. Position the zip tie locking block on top of the pressure fitting.
