November 2017  
FL746A  
NHTSA #17V-588  
Transport Canada #2017-460

## Subject: Western Star Battery Cable Routing

**Models Affected: Specific Western Star 4700 model vehicles manufactured December 17, 2012, through July 14, 2017, with all wheel drive front axles.**

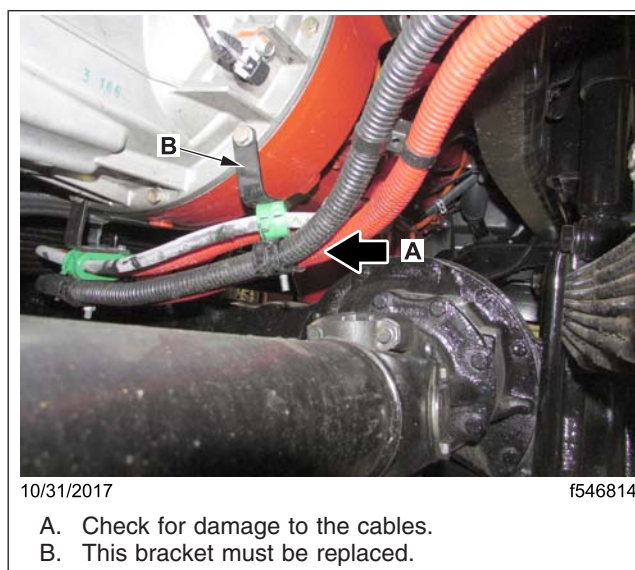
**Fig. 1, Battery Cables Near the Driveline**

1. Check the base label (Form WAR259) for a completion sticker for FL746 (Form WAR260) indicating this work has been done. The base label is usually located on the passenger-side door, about 12 inches (30 cm) below the door latch. If a sticker is present for FL746, no work is needed. If there is no sticker, proceed with the next step.
2. Park the vehicle, shut down the engine, apply the parking brakes, and chock the tires.
3. Inspect the battery cables near the driveline for signs of damage. See [Fig. 1](#).

4. If the battery cables are not damaged, Continue with step 5.  
If the battery cables are damaged (not just the convolute tubing), the battery cables must be replaced. Go to **Battery Cable and Bracket Replacement** on page 8.
5. Loosen the nut on the battery cable clamps to the left of the driveline. This will allow for any needed slack when positioning the cables on the new bracket.
