# SS 1033275 P4 New Cascadia MCM 21 Pin Connector Water Intrusion

## Applicable Vehicles

This solution applies to New Cascadia vehicles with DDC engines.

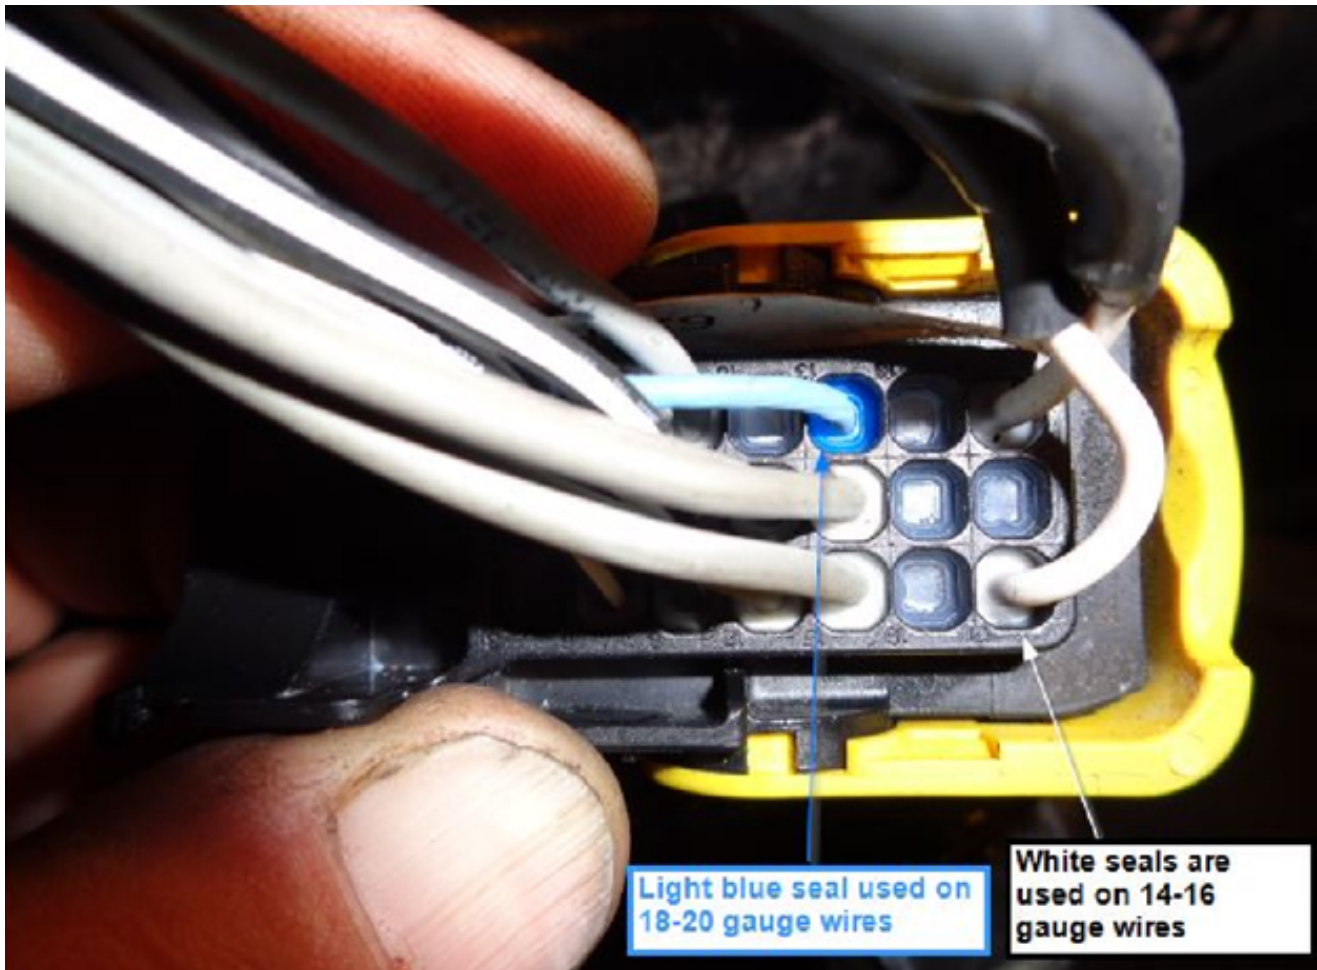
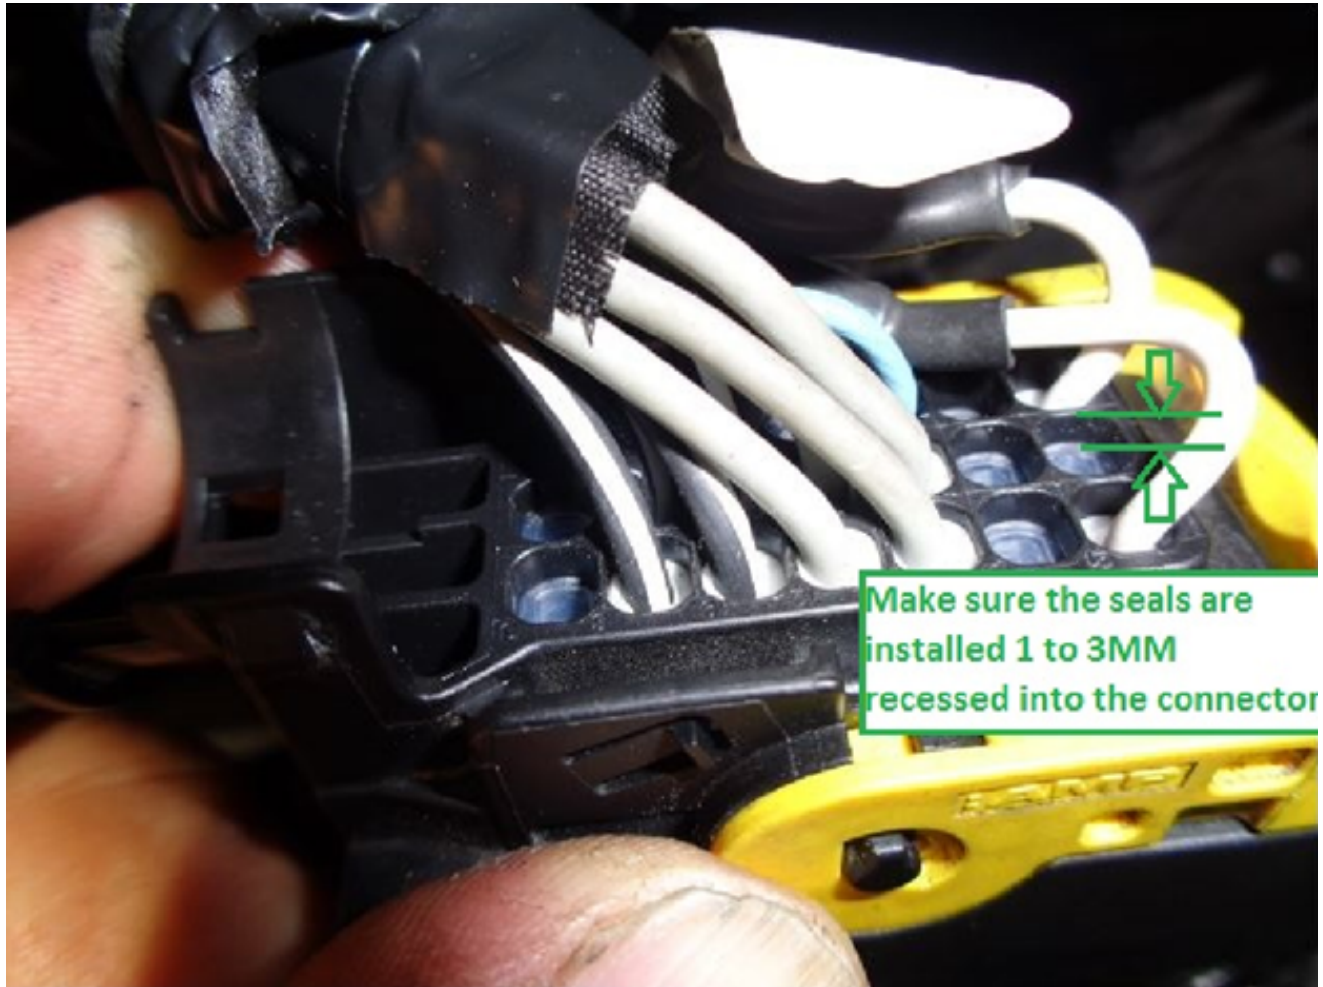
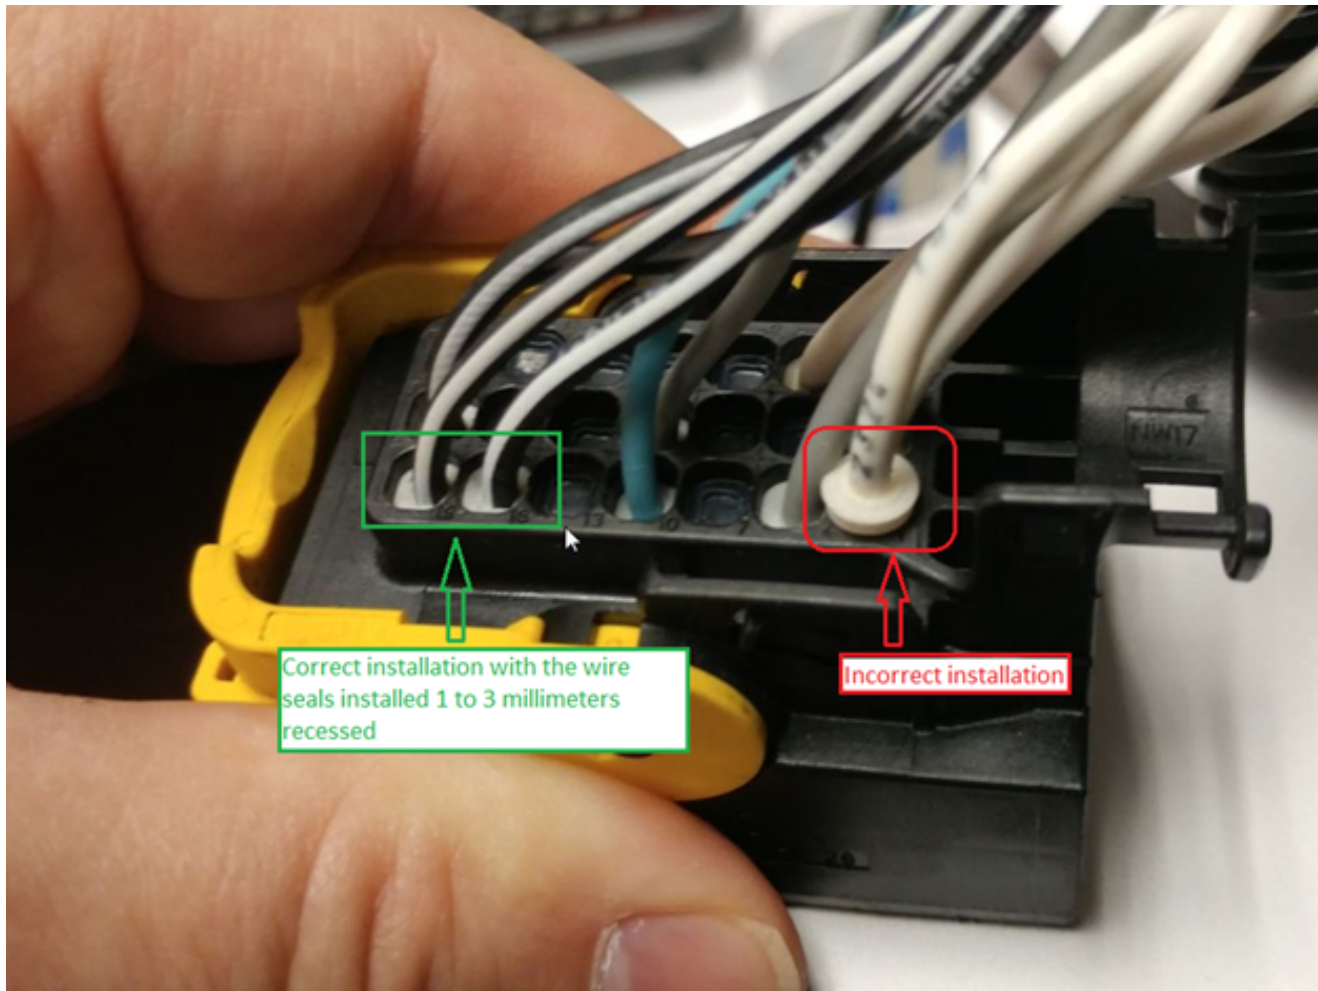
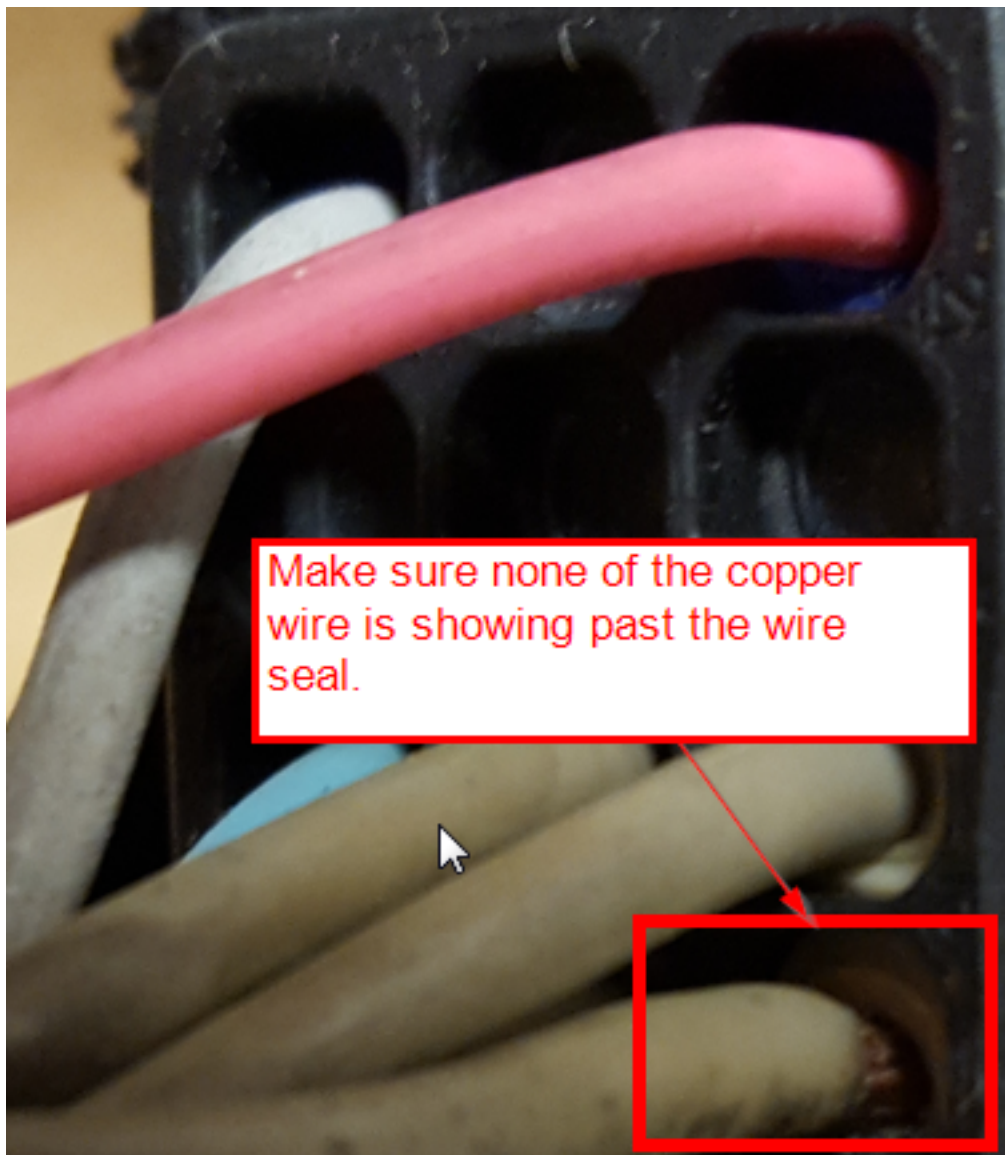
Once water enters the 21 pin MCM connector, it may lead to the terminals and pins becoming corroded. Several factors can attribute to water entering the connector, such as incorrectly installed protective wrapping of the harness, terminal seals not properly installed or seated in the connector and or wrong seals used for the wire size being installed. This solution is being written to aid in the repair of this type of issue, in hopes of reducing water intrusion failures in the future.

Once it has been determined that water is present in the connector, make sure to inspect and replace any of the damaged terminals. General questions regarding replacing or repairing of any harness can be answered in Freightliner Service Bulletin 54-290. Make sure to check the wire seals and plugs validating that the seals are installed 1-3 millimeters below flush and that the correct color seals are being matched with the appropriate wire size.
