JTB00518NAS3

# TECHNICAL BULLETIN

09 JAN 2017

Engine Coolant Expansion Tank Leak

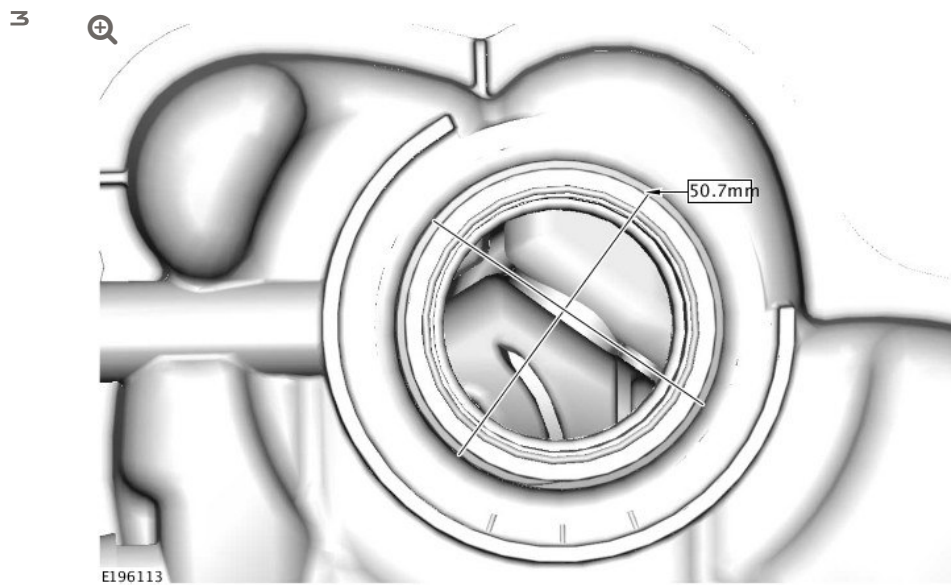
Check the dimensions of the engine coolant expansion tank threaded neck in the two positions shown.

- If the dimensions across the centerline neck are less than 50.70mm, go to Step 5.
- If the dimensions across the centerline of the neck are 50.70mm or greater, go to Step 4.

5 Install a new engine coolant expansion tank and a new coolant pressure cap (see TOPIx Workshop Manual section 303-03: Engine Cooling - Engine Coolant Expansion Tank).

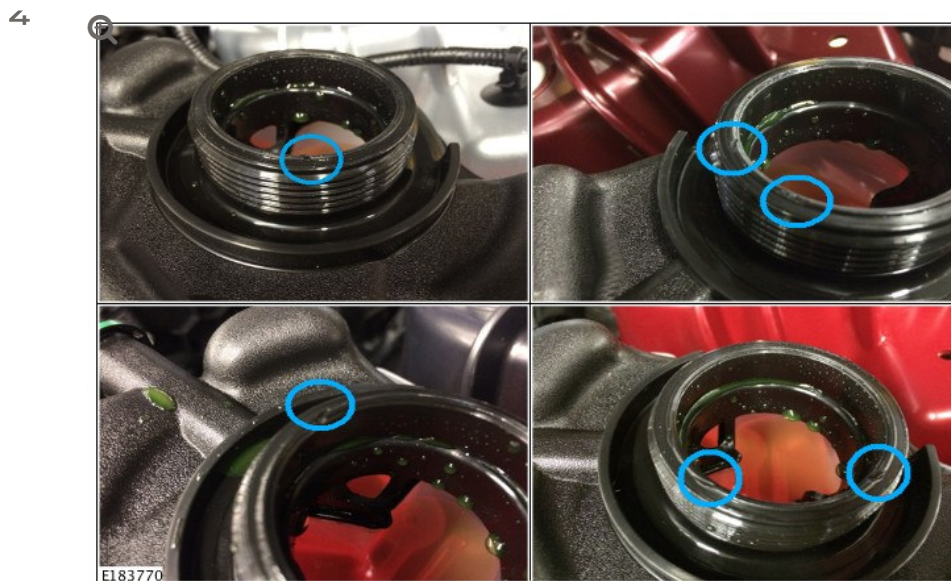
Visually inspect the sealing bead on the engine coolant expansion tank neck to check for damage.

- If the sealing bead is damaged, go to Step 5.
- If no damage is found:
  - Install a new engine coolant expansion tank pressure cap.
  - Top up the engine coolant to the MAX level mark.
  - Run the engine up to normal operating temperature, allowing the electric cooling fan to operate at least once without problem before releasing the vehicle.
  - Switch the engine OFF.
