February 2017
FL721A-E
NHTSA #16V-656
Transport Canada #16-441

Subject: CNG Fuel Tank and CPDM Mounting Location

Models Affected: Specific Freightliner Cascadia vehicles manufactured September 24, 2012, through May 27, 2015, built with CNG fuel tanks

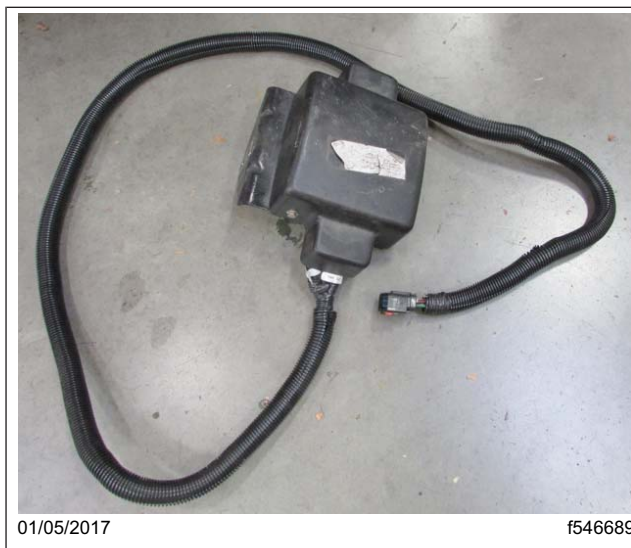
Fig. 30, CPDM Removed from the Vehicle

The chassis power distribution module (CPDM) is located at the back of the cab and beneath the compressed natural gas (CNG) fuel tank. Due to the location of the CPDM, it may be subject to higher than expected levels of water spray and contamination from the road, which may lead to localized melting or burning of the CPDM in close proximity to the CNG fuel tanks. This may increase the risk of a vehicle fire.

NOTE: The CPDM should be discarded after it is removed from the vehicle. It will not be used again.

34. Remove the CPDM from the vehicle. See [Fig. 30](#).
