SI B51 47 16
Body Equipment

CREAKING NOISES FROM C-PILLAR

F36 (4 Series Gran Coupe)		
---------------------------	--	--

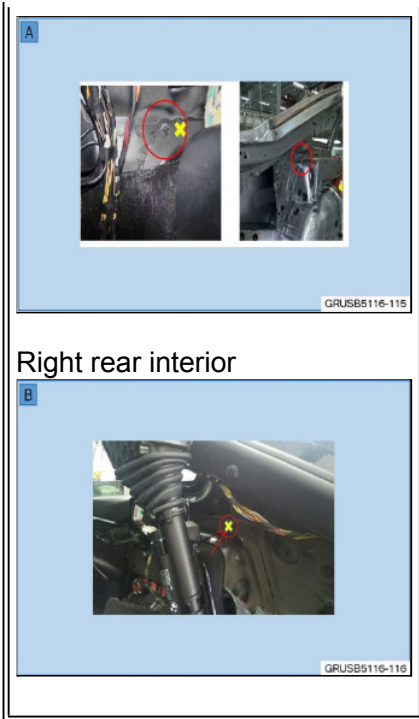
Left rear interior	
--------------------	--

Creaking noises from C-pillar area (either side) while driving on uneven surface.

Flexing of body panels near weld point in the interior side wall.

Note: Putting pressure on the appropriate point will eliminate the noise during flexing.

- Using appropriate tool, slightly dent the body panel at the indicated spot (X) to eliminate flexing.

- Apply corrosion protection to the affected panel as needed.
- Reassemble interior panels and flooring.
