## PRODUCT INFORMATION BULLETIN

November 1, 2017

**SUBJECT:** Availability of Redesigned Mounting System for Code 3<sup>®</sup> Citadel LED Lighting Systems Installed on Ford Police Interceptor Utilities (PIUs)

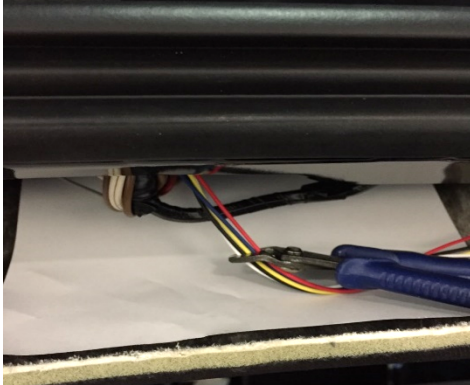
If the wire powering your Citadel looks like this (indicating an independent flashing version):

use product number CITRTF-IF

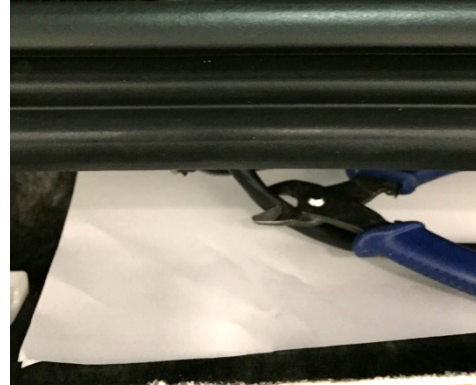
If the wire powering your Citadel looks like this (indicating a controller version – CEL or CB):

use product number CITRTF-CB
