Technical Journal

P5/SPA Software Download Guide

REF NO: TJ 31543.4.4	ISSUING DEPARTMENT: Technical Service	CAR MARKET: United States and Canada	
PARTNER: 3 US 7510 Volvo Car USA		ISSUE DATE: 2017-05-09	STATUS DATE: 2017-05-11
FUNC GROUP: 3018	FUNC DESC: Software	Page 1 of 3

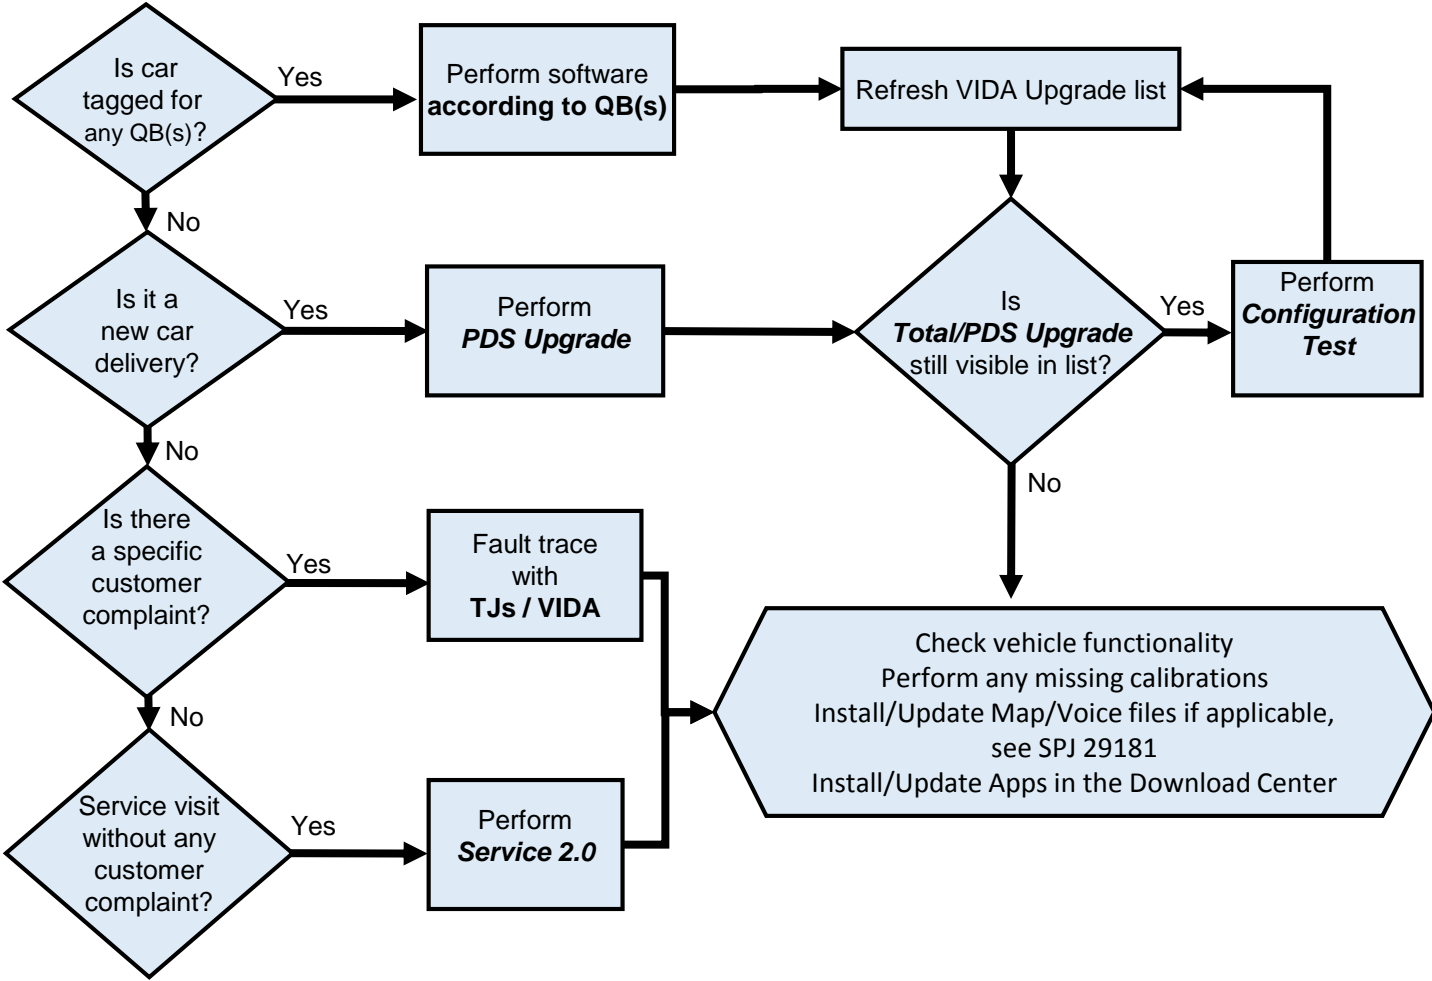
Use VIDA **Service Functions** **12 V power overview** to confirm battery State of Charge is over 70% and positive current is entering the battery.

CEM - Battery State of Charge (SoC)
80 %

CEM - Battery current
14.56 A

SPA SW Guide
Connect battery charger & voltmeter.
