# Vibration/Tapping and/or Misfire After Cold Soak

**Service Category** Engine/Hybrid System

YEAR(S)	MODEL(S)	ADDITIONAL INFORMATION
2013 - 2016	CT200H

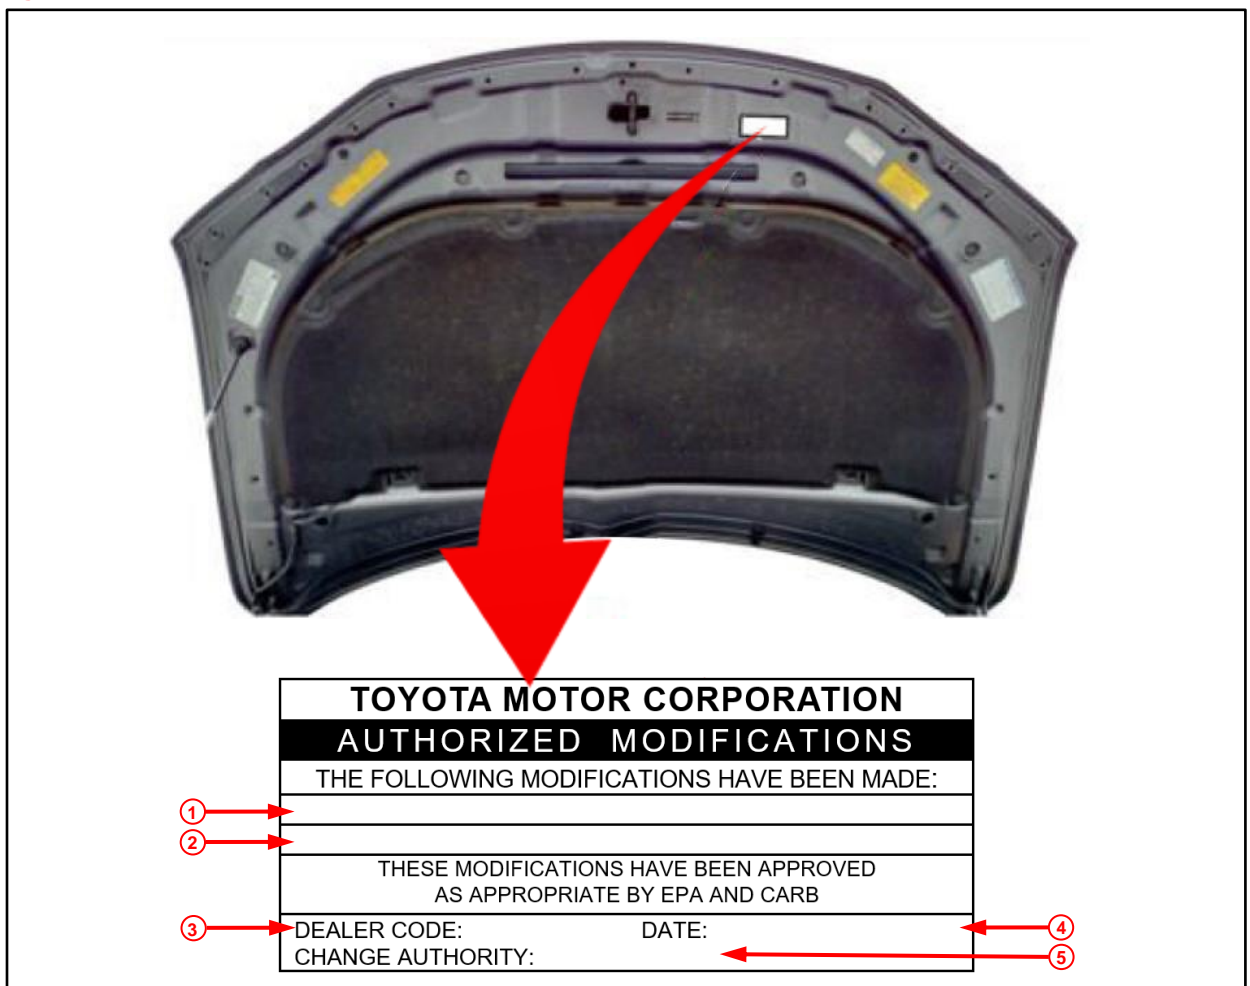
Figure 1. Location of Authorized Modification Label on 2013 – 2016 CT 200h

<b>1</b>	Replacement ECM (PCM) Part Number (i.e., 89660-76014)
<b>2</b>	New Calibration ID (i.e., 37601400)
<b>3</b>	Dealer Code

<b>4</b>	Date Completed
<b>5</b>	This SB Number

2. Check for the Authorized Modification Label affixed to the vehicle in the location shown below. Confirm if the ECM (PCM) calibration has been updated. Is the ECM (PCM) calibration the most recent calibration?
  - **YES** — This bulletin does NOT apply. Continue diagnosis using the applicable Repair Manual.
  - **NO** — Continue to step 3.

4. Prepare and install the Authorized Modification Label.
  - A. Using a permanent marker, enter the following information on the label:
    - ECM part number [Refer to the **Parts Information** section for the **NEW PART NUMBER**]
    - Calibration ID(s) [Refer to the **Calibration Information** section for the **NEW CALIBRATION ID**]
    - Dealer Code
    - Repair Date
    - Change Authority [**This bulletin number**]
  - B. Install the Authorized Modification Label on the vehicle at the location shown in Figure 1. The Authorized Modification Label is available through the MDC, P/N 00451-00001-LBL.
5. Confirm the repair.
  - A. Verify the vehicle no longer exhibits vibration/tapping and/or misfire condition AFTER cold soak.
  - B. Test drive the vehicle to confirm proper vehicle operation.
