Brake Vibration and Lug Nut Torque

Service Category Brake

Section Brake (front)

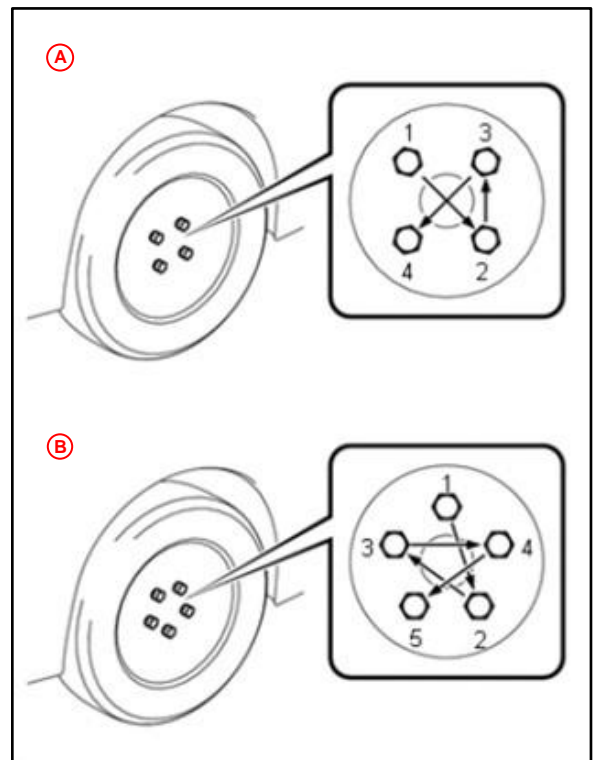
Figure 1.

Some 2015 – 2018 model year Toyota vehicles may exhibit brake vibration due to improper lug nut torque. Brake vibration can occur at any time if improper torque is applied to lug nuts. Even one lug nut over or under torqued can cause vibration.

1. Always refer to the Technical Information System (TIS), applicable model and model year Repair Manual to obtain the appropriate torque value.
2. Apply torque in a star pattern.
