Subject		Market
Various Drivability Concerns and/or DTCs, Corrosion Present in A43 ECM Connector.		USA
Service Category	Section	
Engine/Hybrid System	Engine Control	
Applicability		
Highlander

2014-2017

Highlander

Various Drivability Concerns and/or DTCs, Corrosion Present in A43 ECM Connector.

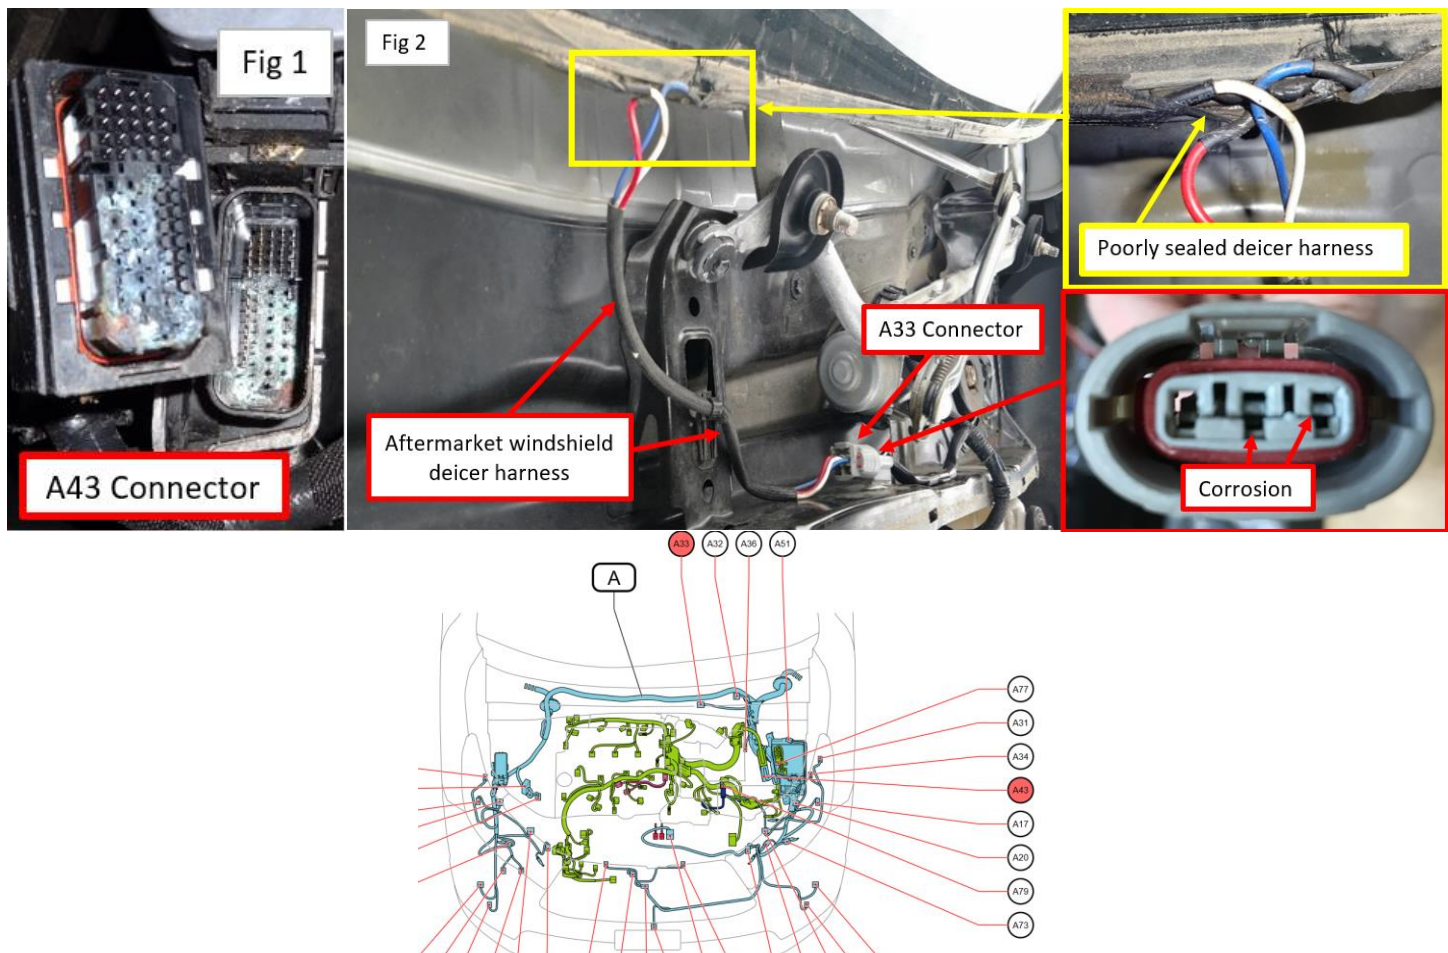
Vehicles may experience various drivability concerns. Upon diagnosis, technicians commonly find no or low fuel pressure as well as a variety of DTCs (Commonly P1603, P1604, P1605, P0171, P0300, P0302, P0304, U0100). Technicians find that the cause this condition is corrosion and water in the A43 ECM connector (Fig 1). In several cases, it was found that the source of water was from aftermarket windshields with poorly sealed or damaged deicer harnesses (Fig 2). Water enters the deicer harness and is wicked through the engine room main harness, eventually collecting in the ECM connector.

- 1) Check for corrosion in the front windshield deicer connector of the engine room main wire harness (A33) (example shown in Fig 2).
- 2) Check for non-genuine Toyota windshields. Toyota genuine windshields will be marked "Toyota" on the glass and have a Toyota part number on the deicer harness (Fig 3).
- 3) Toyota recommends that windshields only be replaced with Toyota genuine parts. Toyota genuine windshields utilize seals to prevent water from entering the engine room main wire harness. In several cases, aftermarket windshields did not have seals to prevent water intrusion.
- 4) If corrosion is found in the A33 connector and the windshield is a Toyota genuine part, please contact TAS.
