## N20 AND N26 ENGINE: HIGH PITCHED WHINING NOISE FROM LOWER ENGINE AREA

E84 (X1 28i)	E89 (Z4 sDrive28i)	F10 (528i Sedan)	F25 (X3)
F30 (320i, 328i Sedan)

Produced before 3/2013

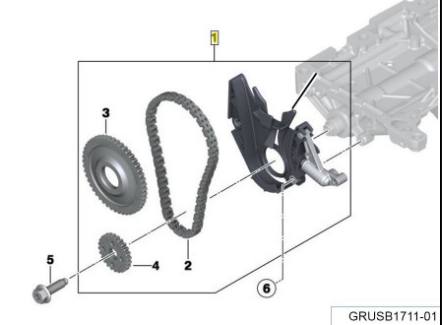
<p>GRUSB1711-01</p>	<p><b>Oil Pump Chain Module Overview</b>          Replace item #1 in the illustration.          Item #1 Chain Drive includes the gears, chain and tensioning device.          The bolts are reusable as per the applicable repair instructions.</p>

7. When authorization is provided, replace the following components as per Repair Instruction 11 41 010 “Removing and installing/replacing chain module for oil pump (N20, N26)”.

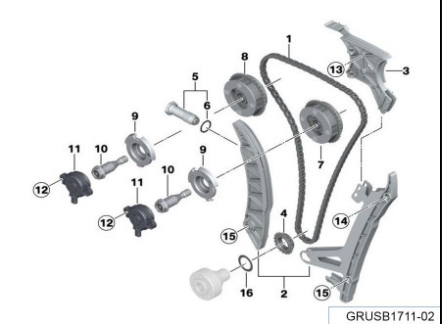
<p>GRUSB1711-02</p>	<p><b>Timing Chain Module Overview</b>          Replace the following components in the illustration.          #1 – Timing chain          #2 – Chain tensioner and guide rail          #3 – Slide rail          #4 – Sprocket          #5 – Chain tensioner with seal</p>

Replace the timing chain module as per Repair Instruction 11 31 051 “Replacing timing chain (N20, N26)”.
