B-PILLAR WIND NOISE

G30 (5 Series Sedan)

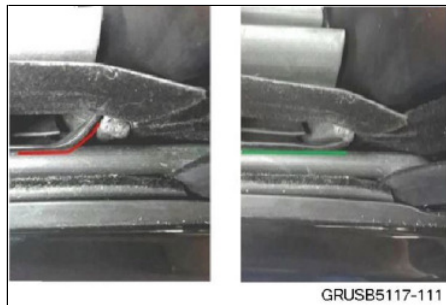
While driving at highway speeds, wind noise can be heard from the rear of either or both front doors.

Sealing lip of inner window cavity seal is bent as shown on left below. Seal placement should be as shown on right, parallel to green line.

Replace seal if necessary.

1. Inspect seal.

Is seal bent as shown in left picture above?

2. Disassemble door trim panel per REP 51 41 000 "Removing and installing left or right front door trim panel".
3. Reinstall the inner window cavity seal according to REP 51 21 330 "Removing and installing/replacing the weather strip on the inside of the front door".
4. Reinstall door trim panel according to REP 51 41 000.
