CREAKING NOISE FROM TAILGATE DURING TRAVEL

F36 (4-Series Gran Coupe)

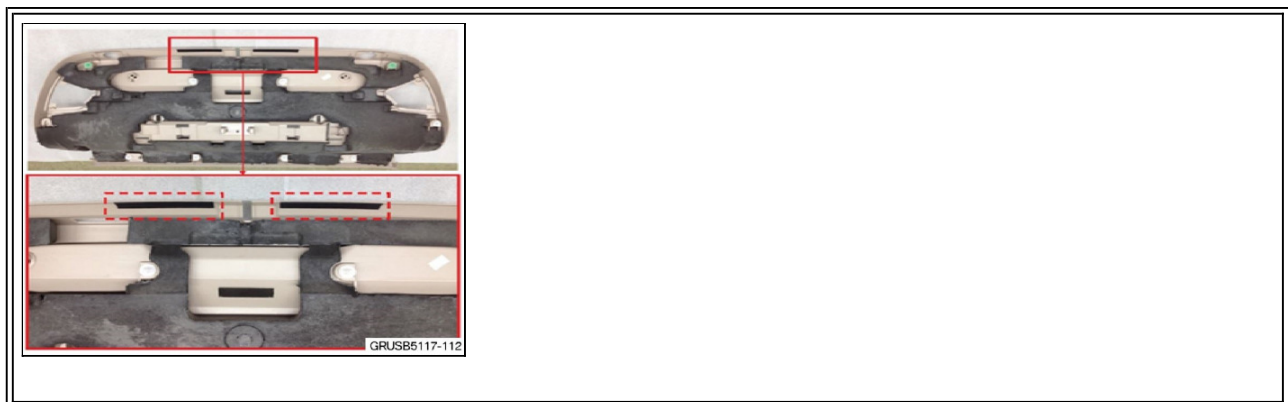
While the vehicle is in motion, a creaking noise is heard from the vicinity of the tailgate.

Friction between trim panel and the tailgate where they make contact.

1. Remove the tailgate trim panel: REP 51 49 000 - "Removing and installing or replacing trim for rear lid."
2. Apply two, 0.8 mm thick felt strips (100 mm X15 mm) to tailgate where shown.
