RATTLE/ POPPING FROM REAR HATCH AREA

F15 (X5)	F16 (X6)	F25 (X3)	F26 (X4)
F85 (X5 M)	F86 (X6 M)

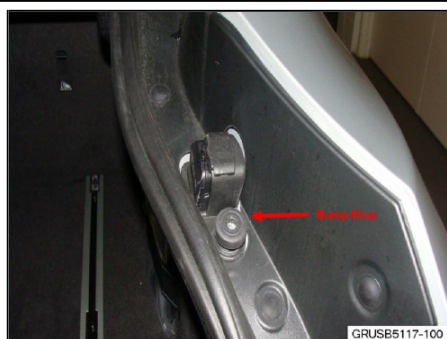
Bump stop height:

- A. Situation A - settling of the bump stops over time allows vibration, rattle of the hatch.
- B. Situation B - the bump stops may be adjusted too high, putting torsional stress on the hatch, causing flexing (popping) noises.

1. Adjust the bump stop height. Refer to repair instructions **REP 51 23 ...Adjusting/replacing bump stops (accessible in ISTA via Group/Subgroup 4162)**.
