CREAKING NOISE ON SIDE OF CONVERTIBLE TOP NEAR CENTER/FRONT

F23 (2 Series Convertible)

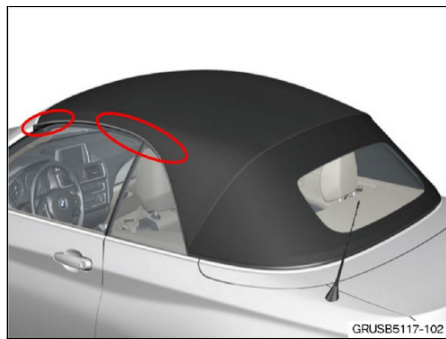
While driving on uneven surface, creaking noises are heard from the area near the top of the window or from the top of the A-pillar.

Friction between convertible seal and the windshield or side window.

Insert stiffeners into convertible top seal.
