Various Check Control Messages Caused by Shorted K-CAN

This Service Information bulletin supersedes SI B61 03 15 dated June 2016.

F22 (2 Series Coupe)	F30 (3 Series Sedan)	F32 (4 Series Coupe)	F34 (3 Series Gran Turismo)
UPDATE! F36 (4 Series Gran Coupe)

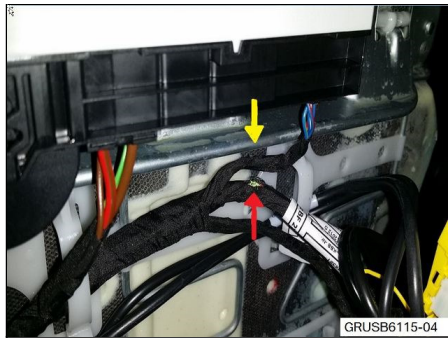
- A. Under driver or passenger front seat.

2. Repair short.
3. Reinstall all components, ensuring routing prevents future wire damage.

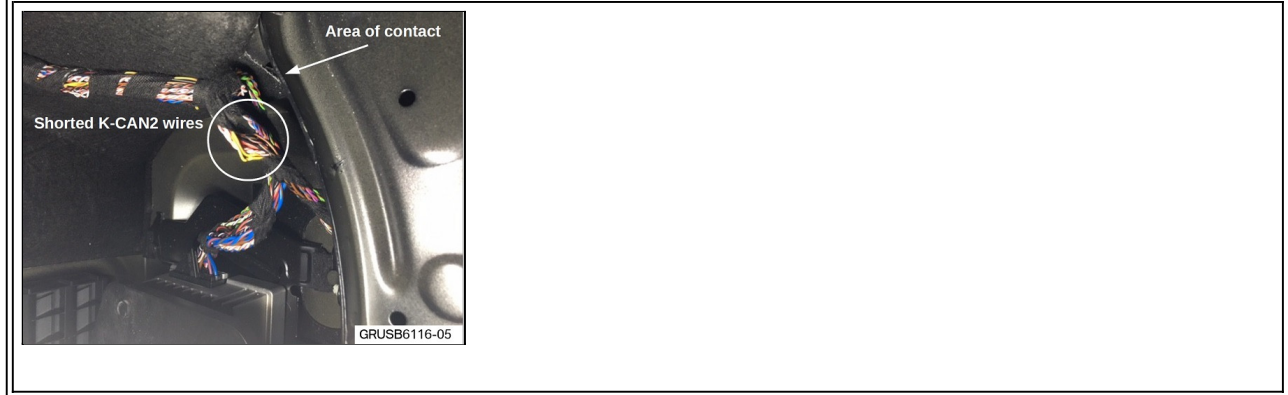
B. Between the left side trunk trim panel and the body

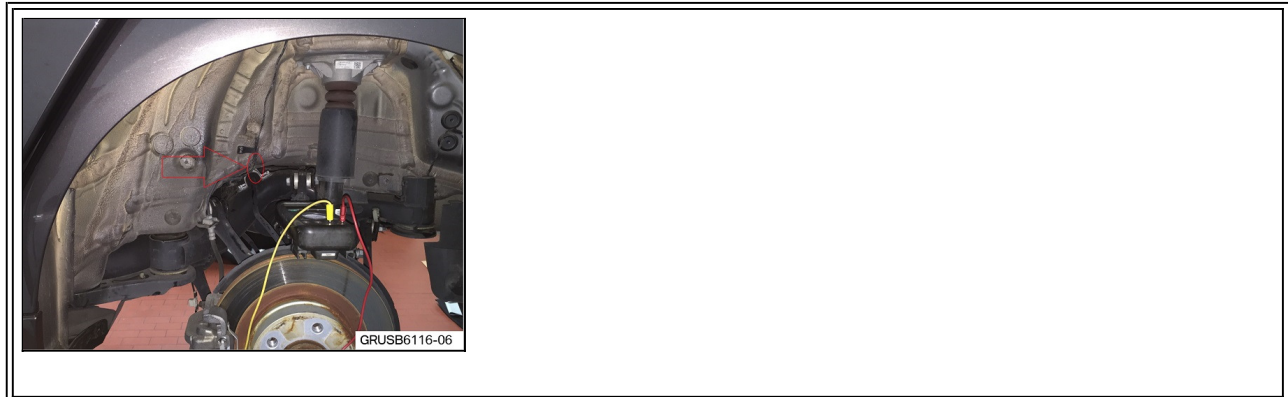
C. On the body in the left rear wheel well area

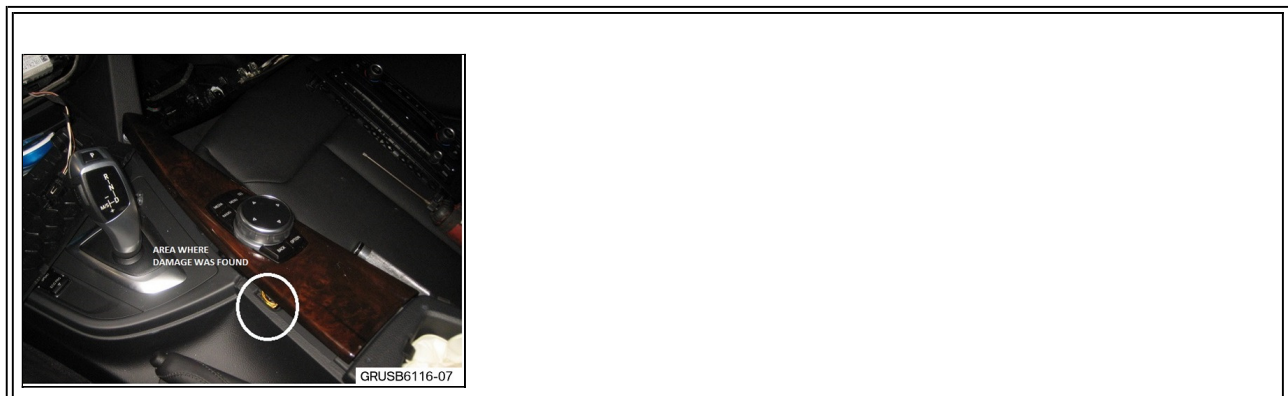
D. Under the center console trim (also check near controller)

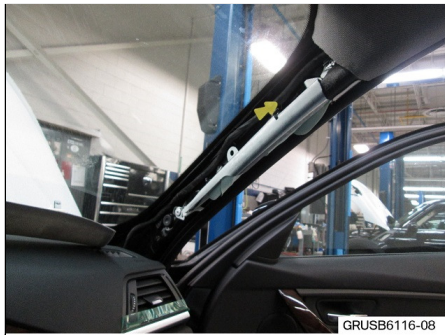
E. Short in A-Pillar behind trim (clip pinching harness)

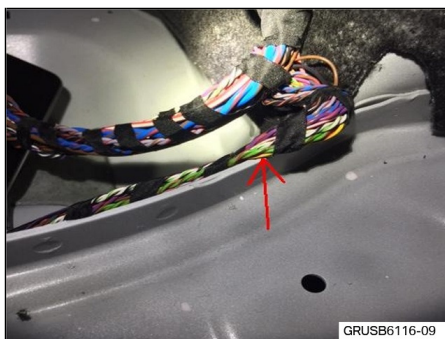
F. Short under left rear inner trunk area (thanks to Eric Zahn at Valencia BMW)
