SI B61 05 17  
General Electrical Systems

## WINDOW WASHER FLOW INTERRUPTION

G30 (5 series Sedan)	
Produced through November 15, 2016

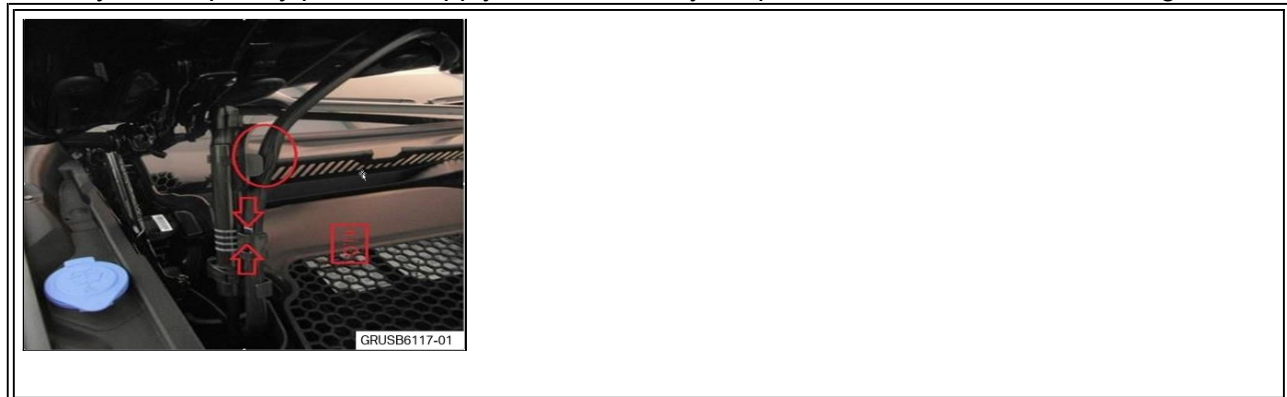
Front windshield washers spray poorly or not at all.

Partially or completely pinched supply tube caused by misplaced tube holder on hood hinge.

Reposition and secure tube holder on the gas pressure spring.
