DELIVERY STOP SERVICE ACTION: CHECK REAR VENTS

F25 (X3)	F26 (X4)
----------	----------

This Service Action involves (9) F25 or F26 produced on January 6, 2017

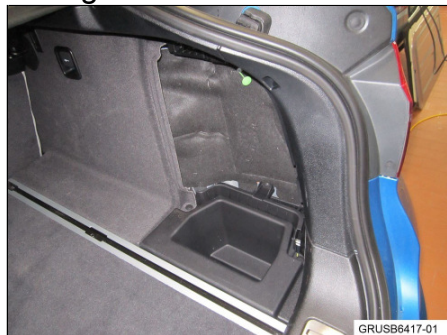
For right rear vent:

1. Remove the luggage compartment flap on the right side.
2. Remove the storage compartment in the right side.

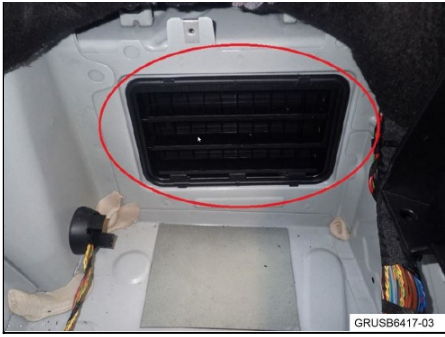
Rear vents may not have been installed properly.

Improper installation may result in water leakage into the luggage compartment.

<p>GRUSB6417-03</p>	<p>4. Check the rear vent at the indicated position (see photo) for tight fit.</p> <p>If the rear vent is not connected properly, it must be corrected.</p>
<p>For left rear vent:</p>
