SERVICE ACTION: SERVICE ACTION: N63T ENGINE - CHECK AND REPLACE THE CRANKCASE VENTILATION HOSES

This Service Information bulletin replaces SI B11 12 16 **dated July 2016**

F01 (7 Series Sedan)	F02 (7 Series Sedan LWB)	F06 (6 Series Gran Coupe)	F07 (5 Series Gran Turismo)
F10 (5 Series Sedan)	F12 (6 Series Convertible)	F13 (6 Series Coupe)	F01 B7 (ALPINA B7)
F02 B7 (ALPINA B7 LWB)	F06 (ALPINA B6)

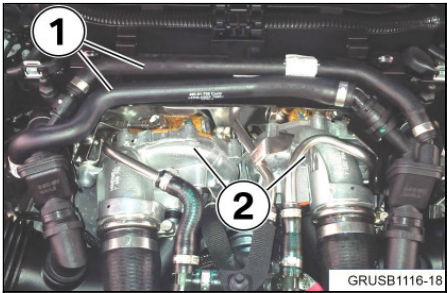
<p>GRUSB1116-18</p>	<p>Hose inspection area with acoustic cover removed. Crankcase ventilation hoses (1). FPM rubber material hoses are shown. Turbochargers (2).</p>

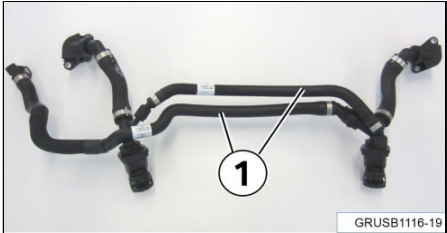
<p>GRUSB1116-19</p>	<p>2. Inspect the crankcase ventilation hoses. If the hoses are constructed of the FPM material (1) then take no further action and reassemble the vehicle.</p> <p>The FPM material will appear to be a smooth rubber hose material.</p> <p>For clarity the hoses are pictured removed from the engine. Do not remove the hoses to make the inspection.</p>
<p>Or</p>	
<p>If the crankcase ventilation hoses are constructed of a plastic coggurated material (1) then the pipes must have all three of the self-locking spacers (2). If these hoses have all three self-locking spacers (2) then take no further action and reassemble the vehicle. For clarity the hoses are pictured removed from the</p>

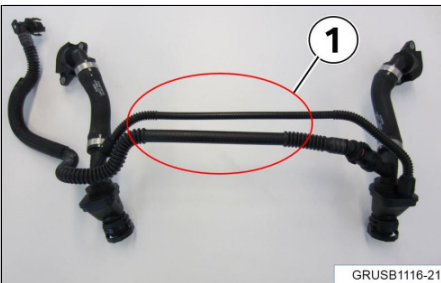
<p>GRUSB1116-21</p>	<p>If the crankcase ventilation hoses are constructed of a plastic corrugated material (1) and the hoses do not have any of the self-locking spacers. Replace both hoses. For clarity the hoses are pictured removed from the engine. Do not remove the hoses to make the inspection.</p>
<p>Or</p>

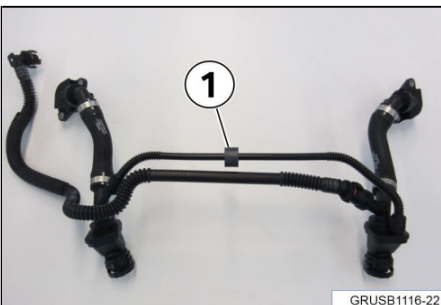
<p>GRUSB1116-22</p>	<p>If the crankcase ventilation hoses are constructed of a plastic corrugated material and any of the three self-locking spacers (1) are missing from the ventilation hoses. Only one self-locking spacer is present (1). Replace both hoses. For clarity the hoses are pictured removed from the engine. Do not remove the hoses to make the inspection.</p>
<p>Or</p>

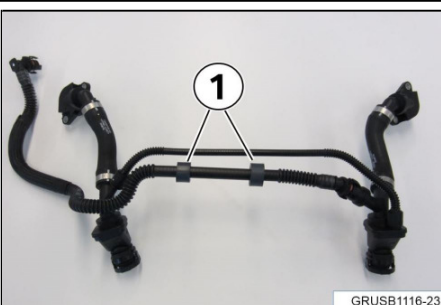
<p>GRUSB1116-23</p>	<p>If the crankcase ventilation hoses are constructed of a plastic corrugated material and any of the three self-locking spacers (1) are missing from the ventilation hoses. Only two self-locking spacers are present (1). Replace both hoses. For clarity the hoses are pictured removed from the engine. Do not remove the hoses to make the inspection.</p>
