SI B41 01 17
Body

SERVICE ACTION: PVC WELD SEAM BENEATH LUGGAGE COMPARTMENT

G30 (5 Series)

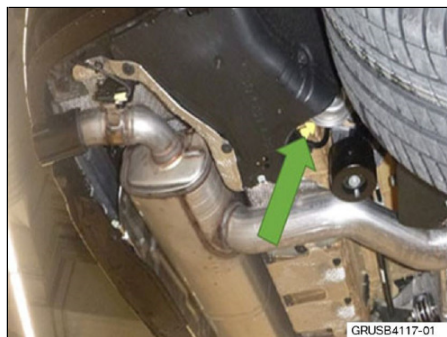
Possible water leakage into luggage compartment through PVC weld on floor.

Improperly applied PVC weld on underside of vehicle, beneath luggage compartment. Drag

1. Raise the vehicle on a lift.
2. Identify the critical area to be repaired as indicated.
