LUGGAGE ROLLER COVER: DIFFICULTY SECURING INTO BRACKET

F31 (3 Series Sports Wagon)

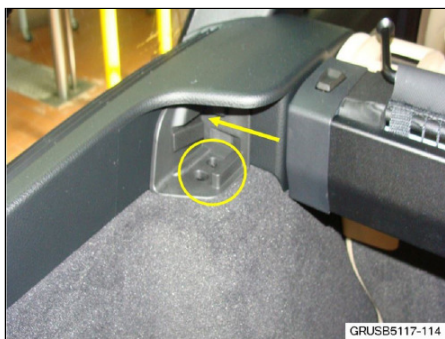
When attempting to secure or release the luggage cover roller into/from the left bracket, it will not easily secure/release.

Left bracket is not accurately installed.

1. Remove luggage cover roller.
2. Loosen both bolts securing left roller-mounting bracket. Reposition bracket approx. 2mm outward (toward left side of vehicle).

3. Screw-in bracket bolts just until they are finger-tight.
4. Check the position of the bracket by attempting to attach/detach the cover roller into/from the bracket.

5. Tighten the mounting bolts.

Tightening Force: 4.0 NM +/- 1.0
