## GROANING NOISE FROM B-PILLAR

This Service Information bulletin supersedes SI B51 40 16 **dated September 2016**.

F26 (X4)
----------

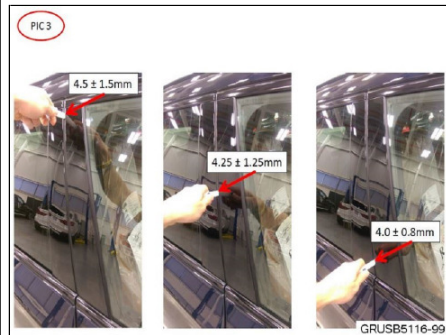
Incorrect gap on the B-pillar trim between the front and rear door, on both the driver's and passenger's sides.

3. Adjust the B-pillar trim gap to the dimensions shown.
4. Tighten the installed screws to 2 Nm.

Note: Overtightening of the screws may lead to damage to the plastic screw-holder clips.
