## EXTERIOR MIRROR: CREAKING NOISES

This Service Information bulletin supersedes SI B51 44 16 dated January 2017.

F22 (2 Series Coupe)	F23 (2 Series Convertible)	F30 (3 Series Sedan)	F31 (3 Series Sport Wagon)
F32 (4 Series Coupe)	F33 (4 Series Convertible)	F34 (3 Series Gran Turismo)	F36 (4 Series Gran Coupe)
F87 (M2 Coupe)

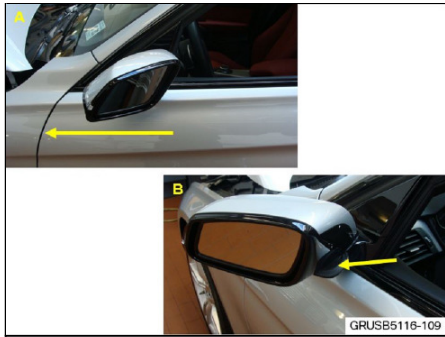
Creaking noise coming from either or both exterior rearview mirrors when folding in.

Accumulation of dust in the joint gap seal.

<ol style="list-style-type: none"> <li>1. Fold the exterior mirror toward the front to expose the joint gap seal (A).</li> </ol>
--	--

2. Clean the exposed sealing surfaces (B) as follows:
  - with compressed air
  - then with a soft brush or cloth.
3. Coat the seal on all exposed surfaces with the lubricant Carbaflo KSP.
