## SERVICE ACTION: CHECK PUMP FOR BACKREST WIDTH ADJUSTMENT

F80 (M3 Sedan)	F82 (M4 Coupe)
----------------	----------------

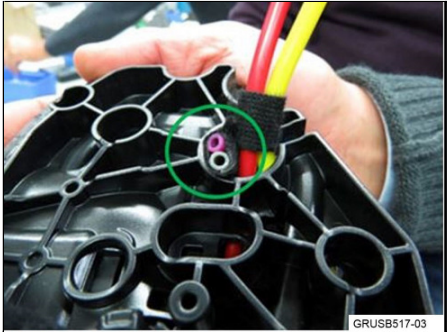
<b>Note on Competition Seat</b></p> <p>Both the lines are not required, the competition seat does not have lumbar support, when replacing the air pump. The unused lines have to be cut off using a suitable tool.  <b>Pay careful attention to the correct line colors when cutting off.</b>  <b>Use the removed part as a reference; see image.</b></p>
