SI B54 04 16  
Special Roofs

## SERVICE ACTION: CONVERTIBLE ROOF: TENSIONING STRAP REPLACEMENT

| F23 (2 Series Convertible) |

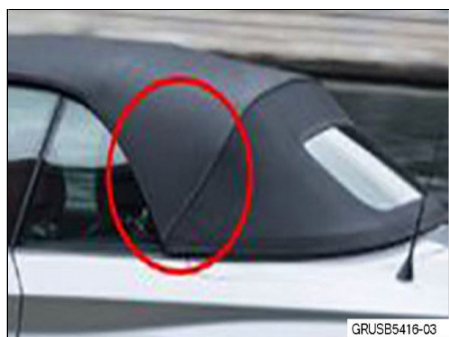
1. Check the headliner for damage in the C-pillar area on the left and right sides.

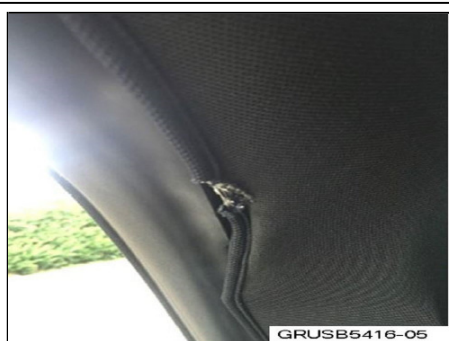
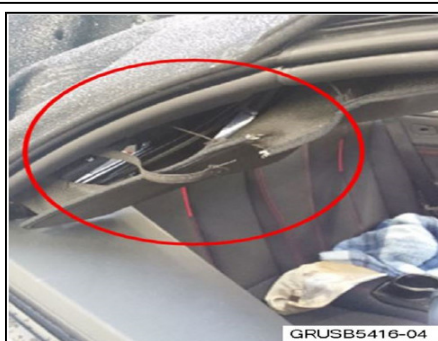
The tensioning strap that is fastened to the headliner could fail during convertible top operation.

Tensioning strap can become jammed or trapped in convertible top mechanism leading to failure.

- Examples of headliner damage

**Is the headliner damaged?**

**YES** – Follow procedure in Headliner Repair Attachment for “Replacing the Headliner”.

**NO** - Follow procedure in Headliner Repair Attachment for “Tension Cable Conversion”.
