## CHARGING SOCKET EMERGENCY RELEASE DAMAGED

I01 (i3 & i3 REx)

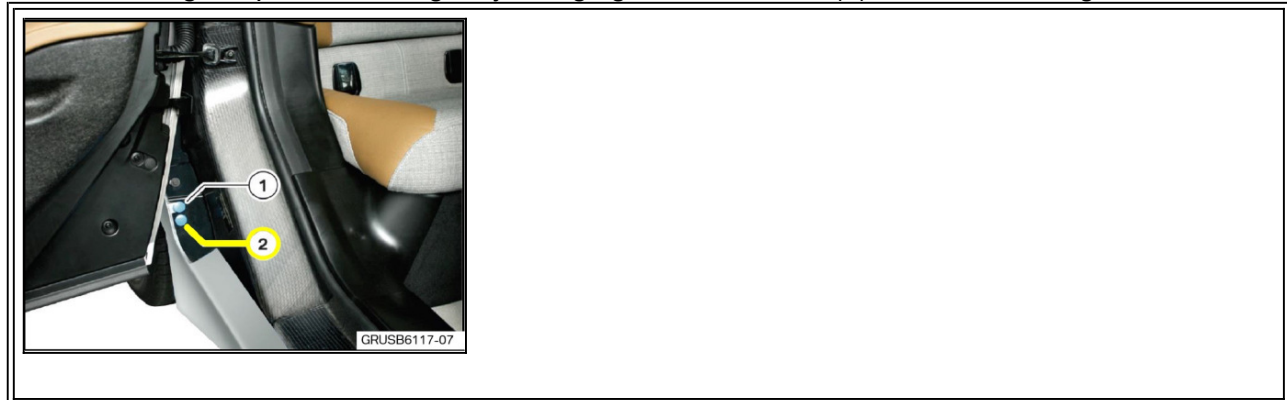
The tensioning strap of the emergency charging socket release (2) has been damaged.

Possible reasons for damage to the emergency release tensioning strap are:

- Excessive force was required to operate the emergency release
- Improper routing of tensioning strap
- Component failure

Replace the supporting strip. The supporting strip has been improved to help the cable glide easier  
Replace the tensioning strap.
